EXISTING FACILITIES NEEDS ASSESSMENT FOR
The South Padre Island Convention Center
For the
City of South Padre Island, Texas
June 1, 2012

Existing Facilities Needs
Assessment for The South Padre
Island Convention Center

Convention Center Assessment

Mechanical Systems Overview

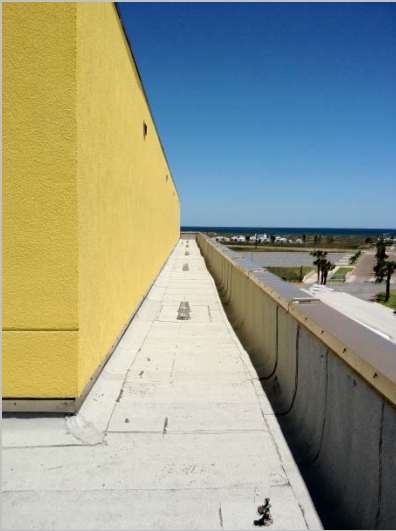
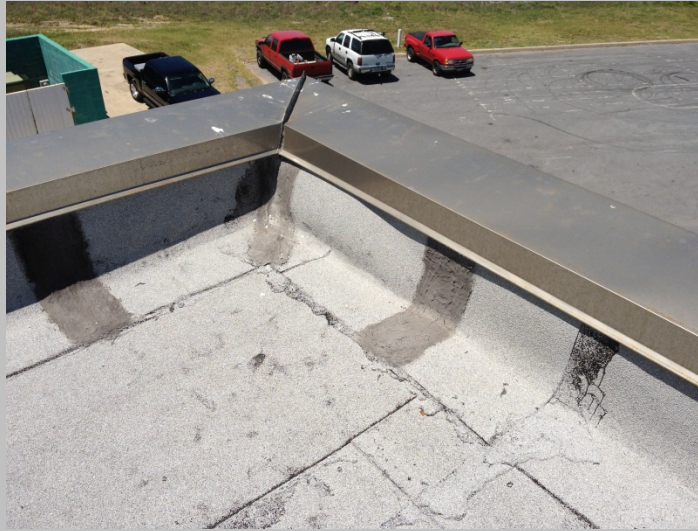
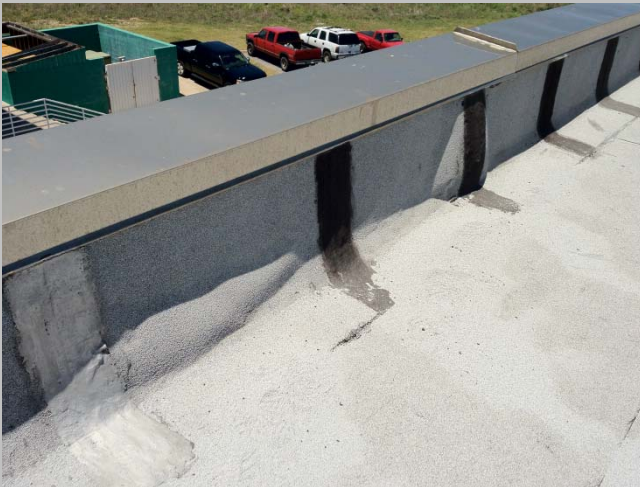
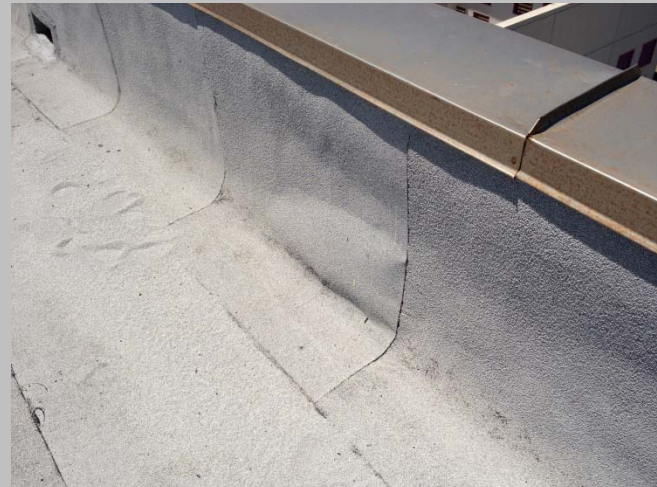
After 4 years of wear, the new roof is holding up well. As shown in the photos below, there are some signs of membrane delaminating and water ponding. This is covered by the roof warranty and efforts should be made to contact the roof manufacturer to remedy these conditions.

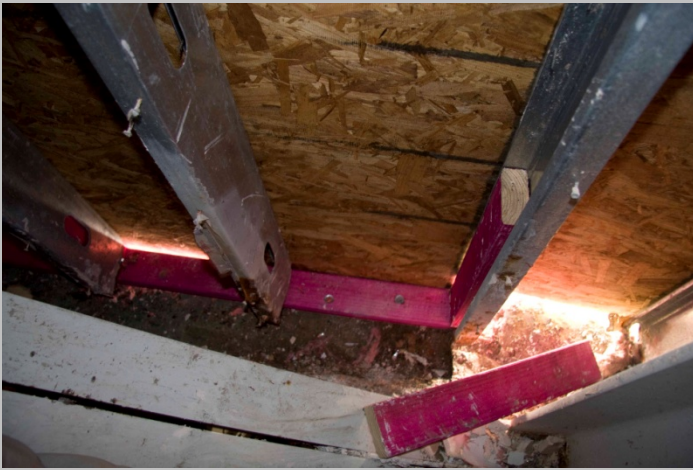
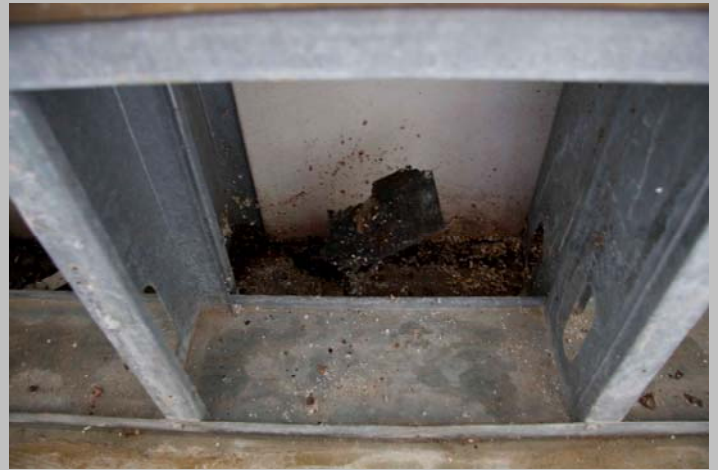
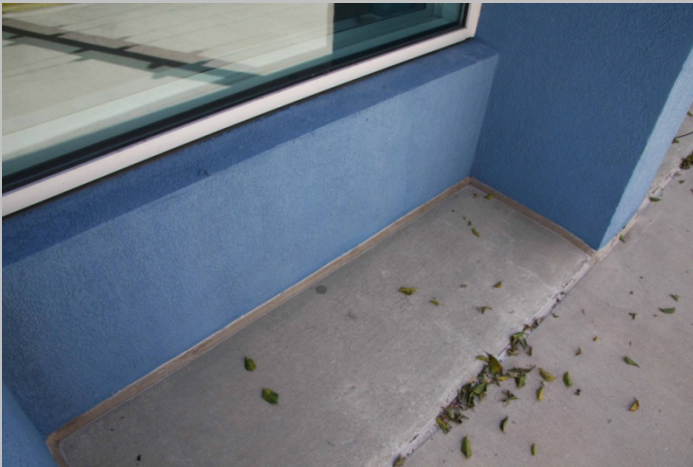
Our observations led us to believe that the exterior walls of the facility lack an important vapor or water barrier membrane(s) within the wall. Pictures show this deficiency in the wall that collapsed and other perimeter walls. All these wall show significant corrosion to the vertical metal studs and bottom track. In some cases, the bottom track has completely corroded and is nothing more than metal dust. No vapor barrier, base flashing, or weep hole are visible. These are very important components that belong in the cavity of the wall for they allow the intruding moisture a way to weep out of the wall. It's very possible that more walls will collapse if you do not repair the bottoms of these exterior metal stud walls. Furthermore, we recommend installing vapor barriers, base flashing and weep holes. This will be a very intrusive repair.

It is our recommendation that the highest priority in any renovation effort should be to replace all exterior wall studs with new stud walls or concrete block. In lieu of the existing EFIS system, a convention stucco exterior should be installed. In this way, the wall would have an integral vapor barrier that work in concert with through and base wall flashing. Weep holes at the bottom of the wall will ensure that any moisture is wicked out of the walls.

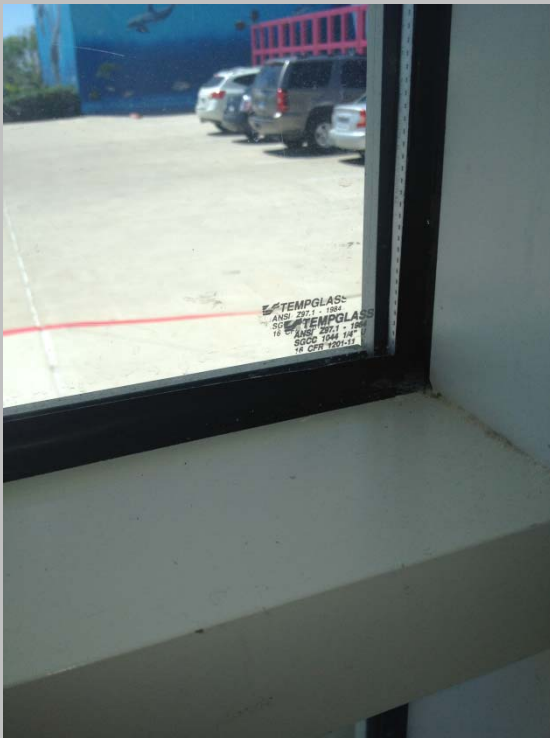
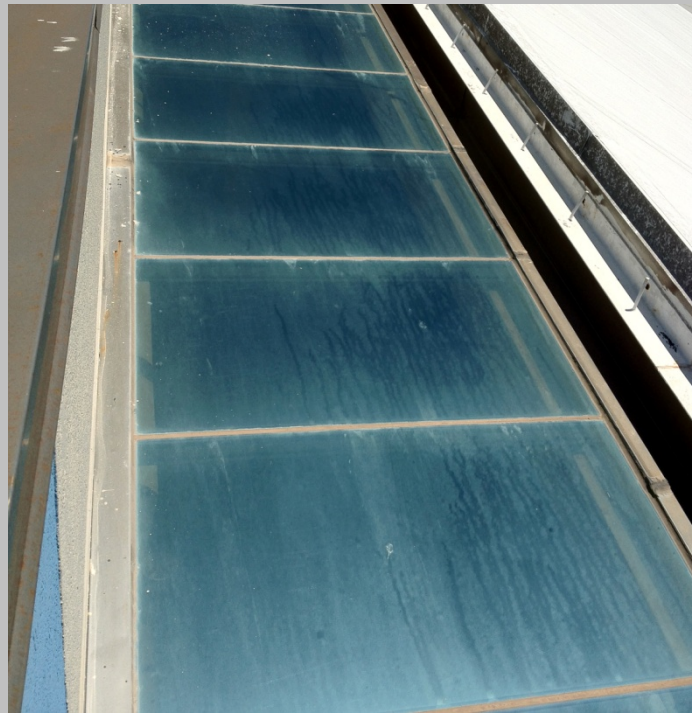
The sky light at the main lobby has and does leak. Visual inspection shows wear at the gaskets. Replacing all gaskets should illuminate the problem. As reported by Convention Center staff, this is a constant problem.

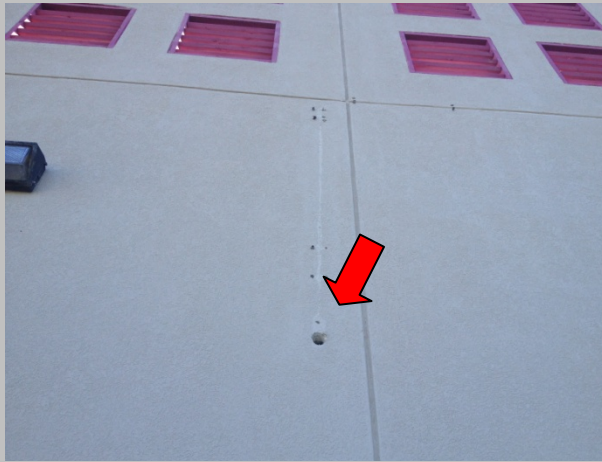
1. Some punctures present in the exterior EIFS. (Photo #1)
2. Column base cracks present at west side walkway. (Photo #2)
3. Some evidence of movement visible in the form of cracks and separation of expansion joints at the west side walkway. (Photo #3)
4. Blistering of the roof cap sheet was observed at the base of flashing in several areas. (Photo #4)
5. Secondary drainage of the roof system is not present near the entrance of the Exhibit Storage area. (Photo #5)
6. Loss of fasteners and moderate to severe corrosion was observed at the support of the chiller unit located within the exterior mechanical room. Moderate corrosion was observed at some mechanical units. (Photo #6 and #7)

Photo #1 Puncture of EIFS exterior located at west side wall of Exhibit Storage area.

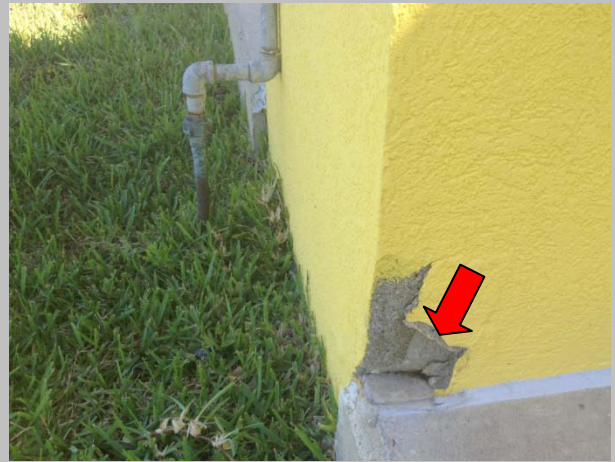
Photo #2 Column base crack at west side walkway.

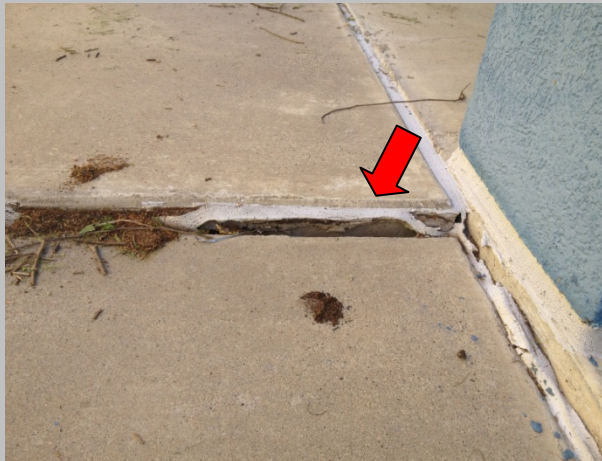
Photo #3 Separation of expansion joint at west side walkway and building slab.

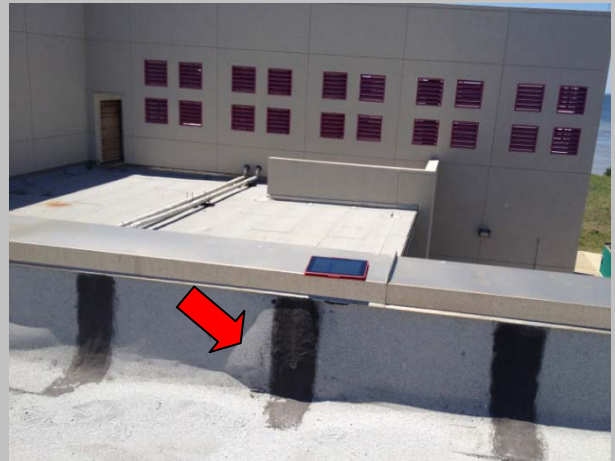
Generally, the roof system is in good condition with isolated areas of blistering of the cap sheet and some evidence of ponding along the central canopy/main lobby area. The roof near the Exhibit Storage entrance area does not have a secondary drainage system.

Photo #4 Blistering of cap sheet at base of flashing near Exhibit Hall and Loading Area.

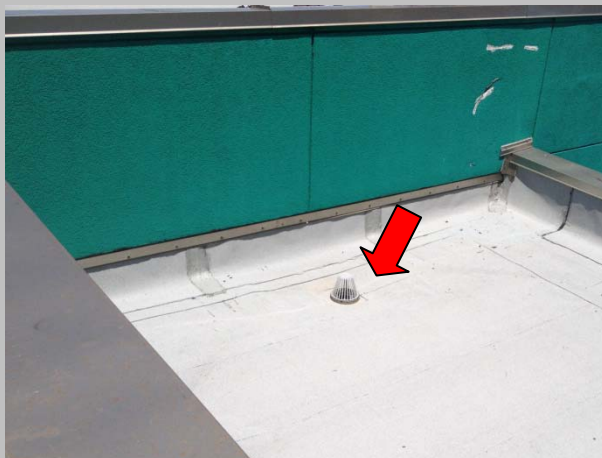
Photo #5 No secondary drainage; puncture of EIFS exterior near Exhibit Storage entrance.

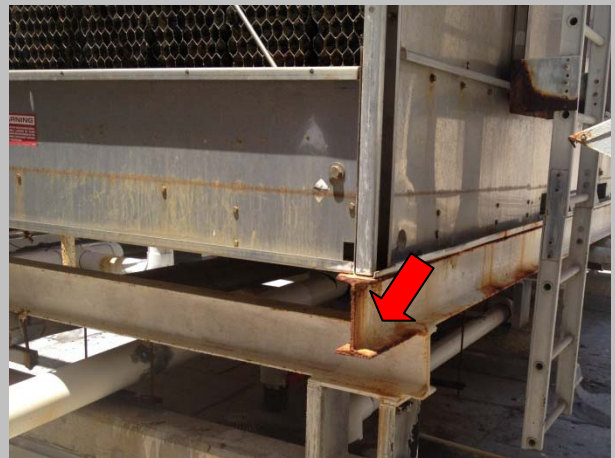
The exterior steel members used to frame the central canopy have experienced moderate corrosion. The cooling tower unit support at the exterior mechanical area has undergone moderate to severe corrosion and loss of fasteners. Moderate corrosion is used to describe larger scale chipping and delamination of coatings, minor volume expansion and/or minor delamination of the base metal. Severe corrosion is used to describe larger scale volume expansion, delamination of the base metal and/or through-section loss of the base metal.

Photo #6 Moderate to severe corrosion at support of mechanical unit located at the Exterior Mechanical Area.

1. Replace the cooling tower unit support at the exterior mechanical area.
2. Replace steel frame supports at central canopy/main lobby that have undergone more severe corrosion.
3. Replace or repair exterior wall metal studs and bottom tracks that have experienced severe corrosion and minimize the potential for future corrosion by implementing an adequate moisture protection system.
4. Replace the aluminum windows at the clerestory windows located along the central canopy/main lobby area.
5. Replace all storefronts, aluminum windows, glazing at skylight and clerestory, and louvers with those meeting the requirements set forth in IBC 2006.

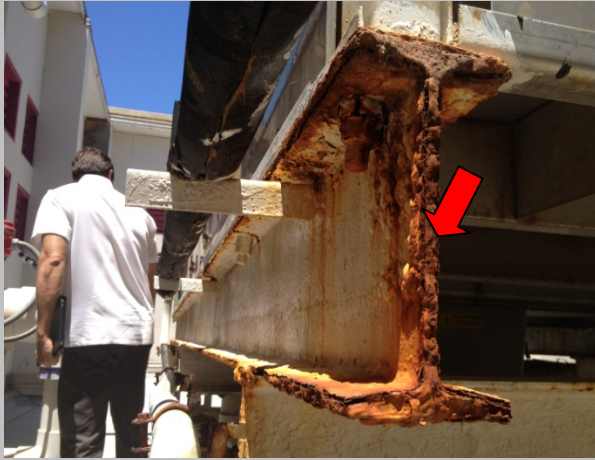
Photo #7 Loss of fasteners and sever corrosion of support of mechanical unit located at the Exterior Mechanical Room.

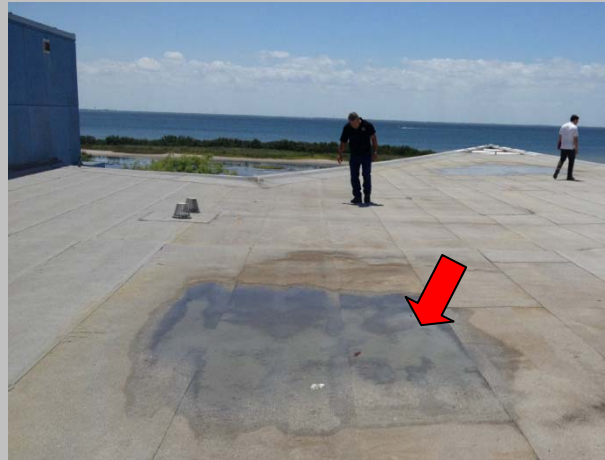
8. Evidence of ponding is present at various locations of the central canopy/main lobby. (Photo #9)
9. Degradation of sheet rock and metal studs observed below door to cooling tower. (Photo #10)

Photo #9 Evidence of ponding at central canopy/main lobby area.

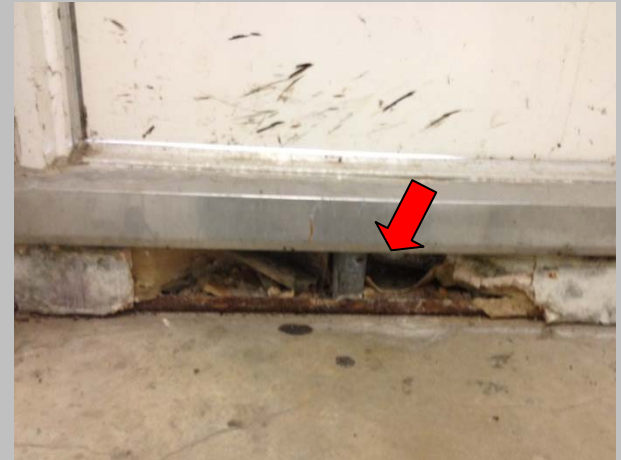
Photo #10 Degradation of sheet rock and metal studs below door to cooling tower.

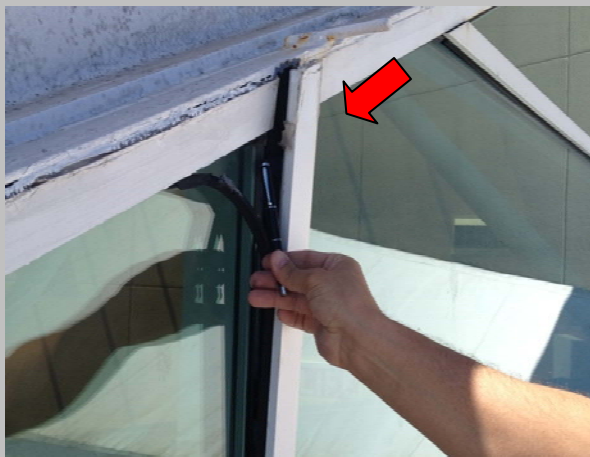
10. Failed sealant and damaged mullion was observed at the aluminum window assembly at the canopy/main lobby clerestory windows. The rubber compression gaskets appear weathered and may lead to water infiltration in the future. (Photo # 11)

Photo #11 Failure of sealant and loss of mullion at aluminum window at central canopy/main lobby area clerestory windows.

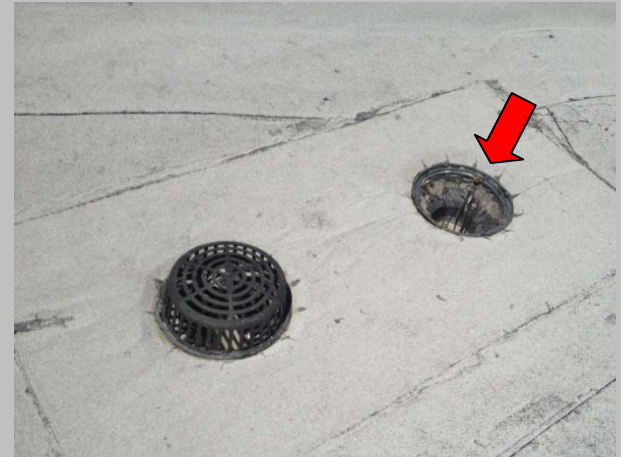
Photo #12 Secondary drain dome missing.

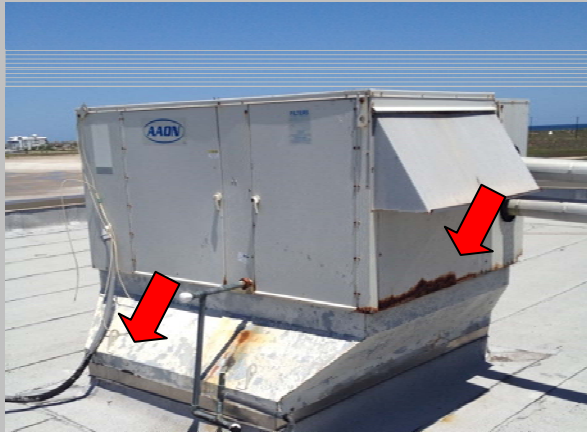
11. Moderate corrosion of exterior mechanical equipment. (Photo #13)
12. Moderate corrosion of the exterior steel members that frame the central canopy system was observed. (Photo #16 and #17)

Photo #13 Moderate corrosion of mechanical equipment. Adapter roof curbs at base of mechanical equipment.

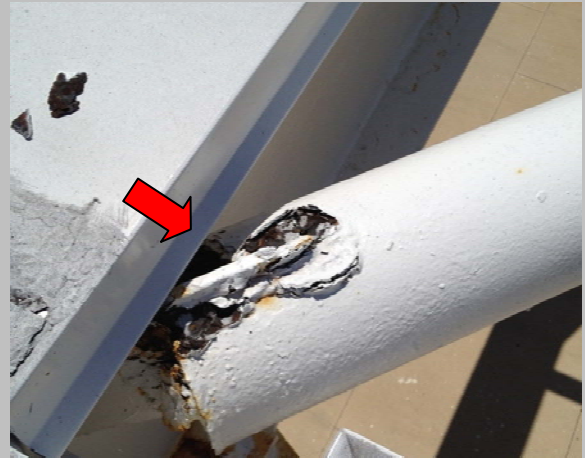
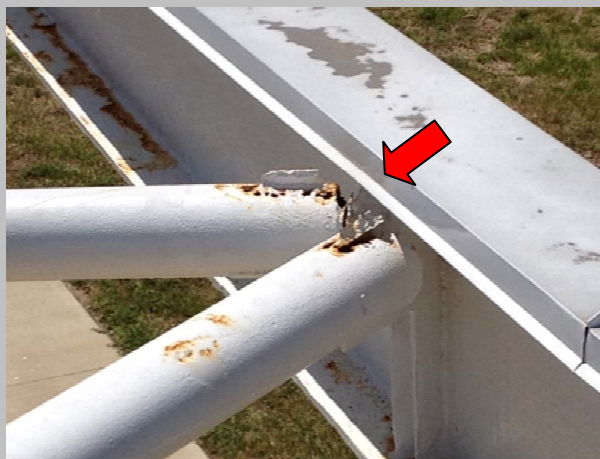
Photo #16 Corrosion of west side central canopy members.

Photo #17 Corrosion of west side central canopy members.

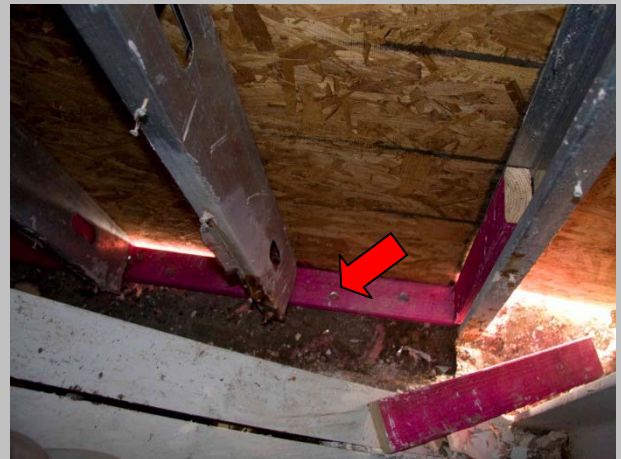
13. Moderate to severe corrosion of exterior wall metal studs and bottom track as evident in photograph No. 13 provided by ROFA. (Photo #18)

Moderate to severe corrosion of the exterior wall studs and bottom track is also evident based on documentation provided to GRA. Corrosion of these members is more than likely the result of moisture intrusion due to an inadequate or failed moisture protection system. Loss of these members could potentially result in a wall loss in the event of high wind events.

Photo #18 Corrosion at bottom of exterior wall metal studs and track at northeast side of facility. Photo provided by ROFA.

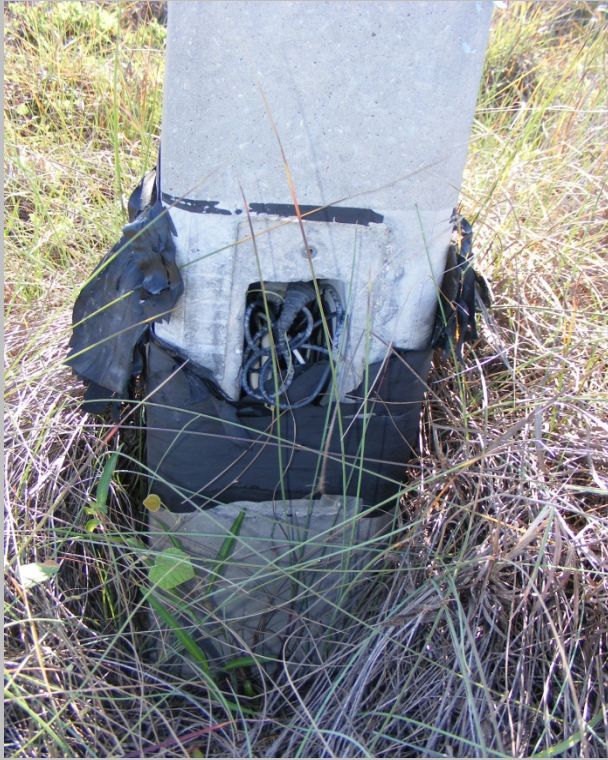
Hand-hole covers are also missing at the base of some concrete poles, exposing the lighting branch conductors.

All exterior panelboards and light fixtures are experiencing severe deterioration due to the corrosive environment. All exterior panelboards should be replaced with fiberglass enclosures to avoid premature failures. The parking lot lighting fixtures and supports should be replaced and all concrete poles missing hand-hole covers should be provided with appropriate covers. All landscape in-ground lighting fixtures and building-mounted light fixtures should all be replaced due to their weathered and rusted condition. The security light fixtures mounted on the wooden should be replaced and provided with watertight connectors. All steel disconnect switches and mounting hardware serving mechanical rooftop equipment should be replaced with stainless steel disconnect switches. There are some disconnect switches that have recently been replaced with new fiber glass enclosures. We recommend that all mounting hardware be replaced with stainless steel hardware.

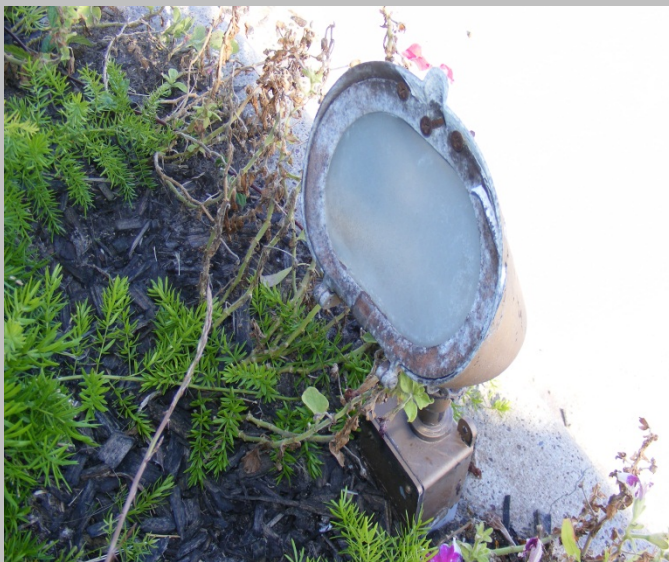
The landscape lighting fixtures are showing signs of oxidation. Metal screws used to secure the lens on these light fixtures are also rusted.

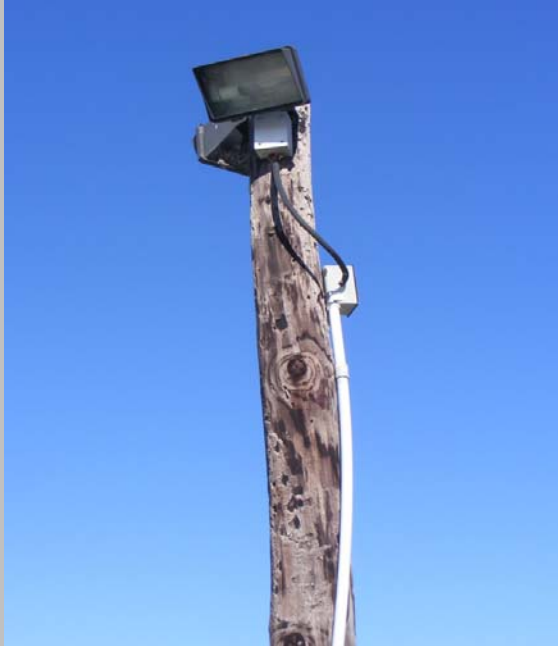
The security lights located near the parking lot are mounted on a wooden pole and appear weathered and rusted. The junction box steel connectors are also rusted and are not watertight. The PVC conduit connected to the junction box is not properly secured to the pole.

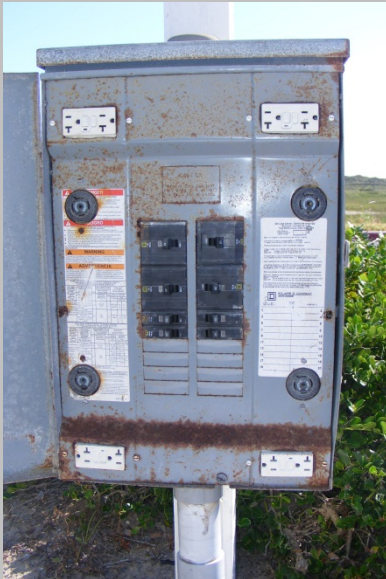
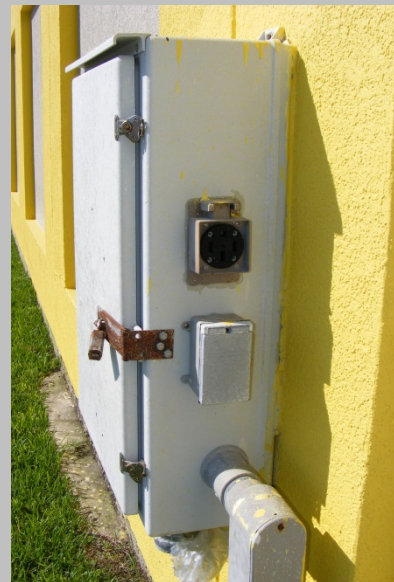
The exterior road show panelboard located in the parking lot closest to the convention center is rusted. The panelboard that is secured to the north side of the building is also rusted.

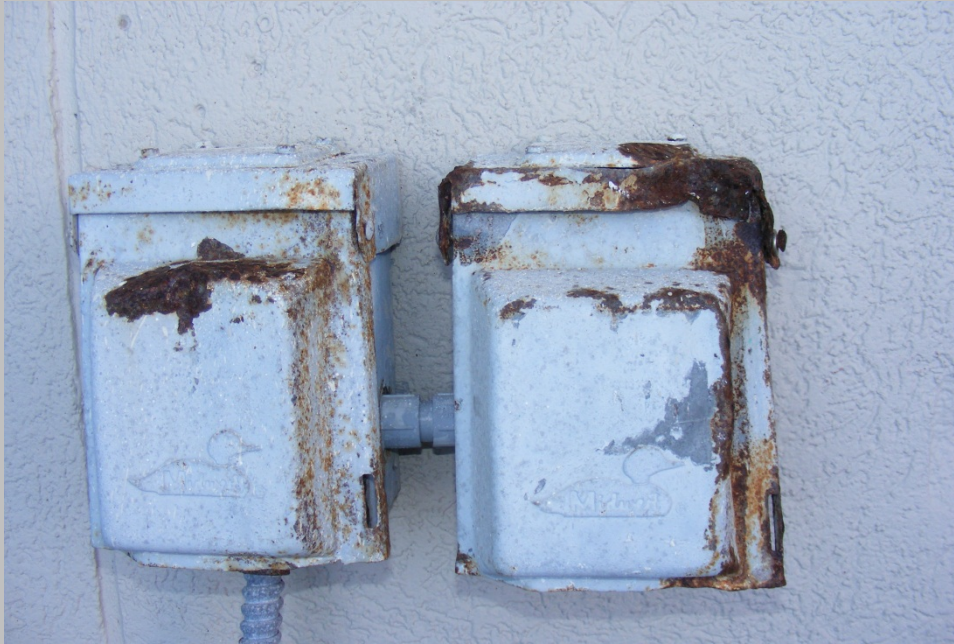
The NEMA 3R disconnect switches located in the loading dock are rusted and weathered.

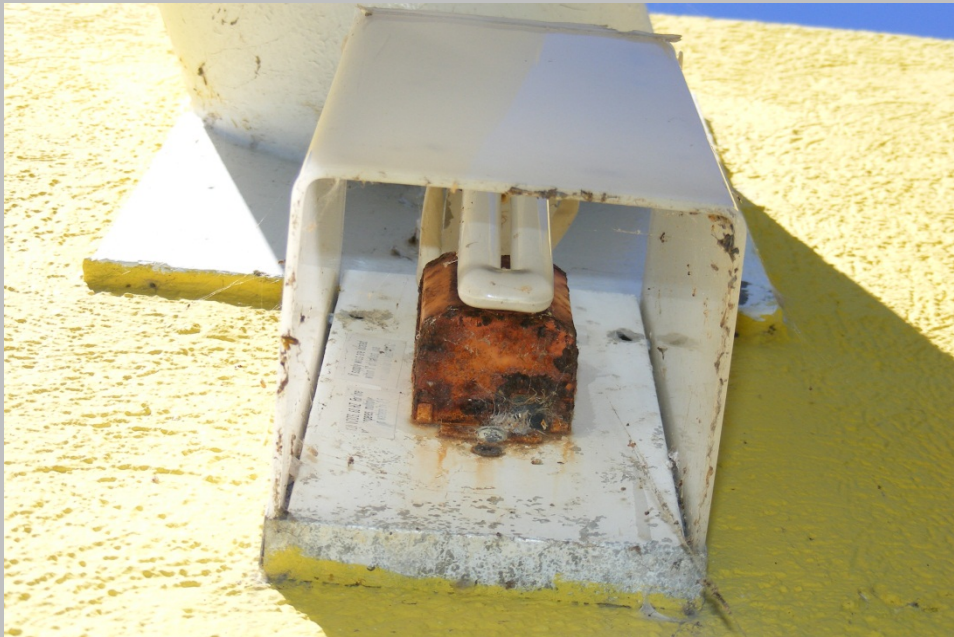
The surfaced mounted light fixtures along the walkway of the northwest quadrant are rusted and weathered.

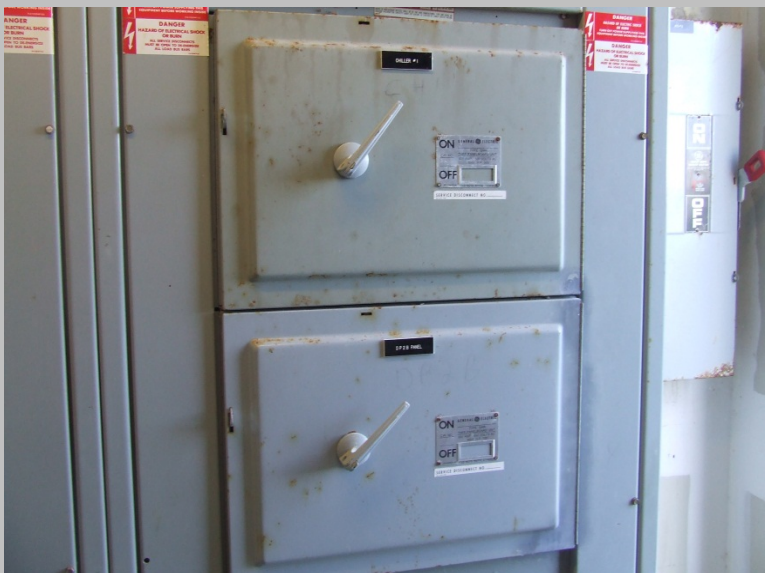
The main switchboard enclosure, located in the main electrical room, is beginning to show signs of corrosion. This is due to its close proximity to an exterior door, and the electrical room is not air conditioned.

Provide new load description labeling on all distribution and branch panelboards. Replace all dry-type transformers with new efficient, NEMA TP-1, style transformers. All electrical connections in distribution and branch circuit panelboards should be re-torque per the manufacturer's recommendations. In the main electrical room, the main switchboard shall be inspected for rust on internal components. If rust is detected, the switchboard should be replaced. The interior components of the electrical equipment in secondary electrical rooms should also be inspected for rust. Electrical rooms should be properly sealed and air conditioned in order to minimize exposure to the outdoor environment.

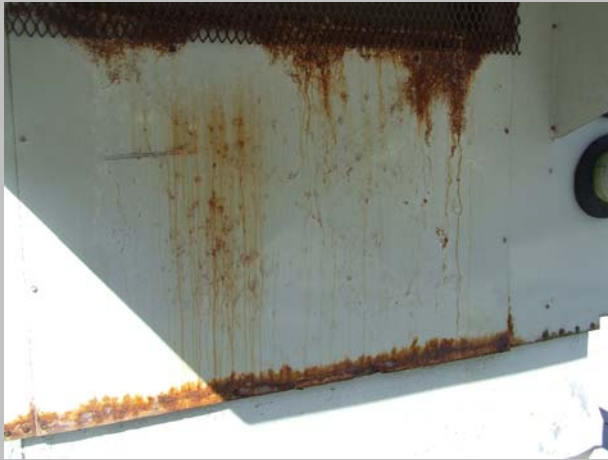
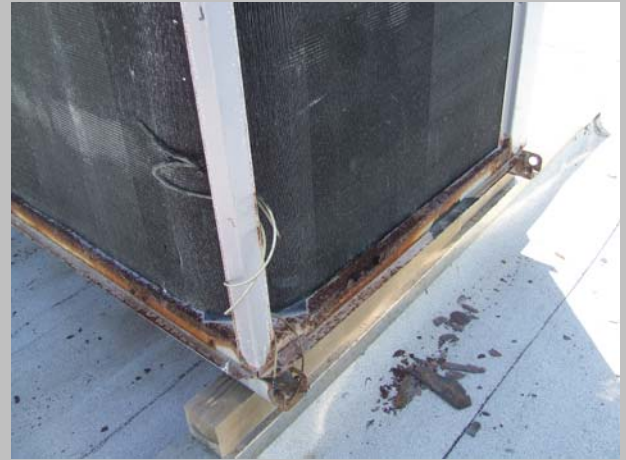
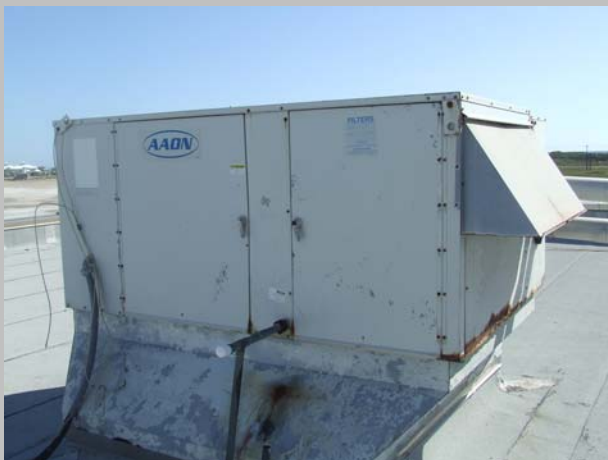
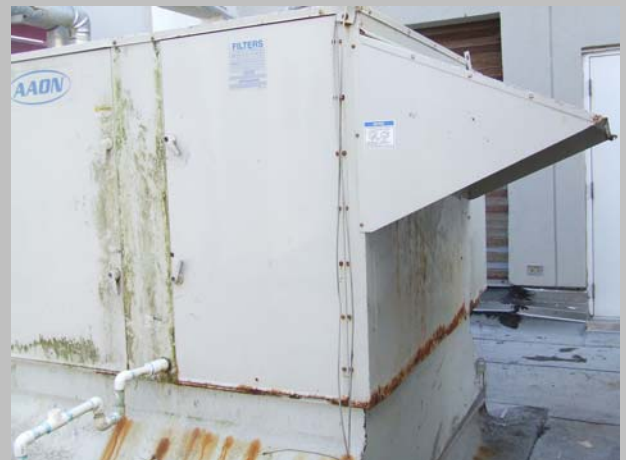
3. All of the rooftop equipment and condensing units have a remaining useful life of 5 years or less due to corrosion.
