January 7, 2013

Re: South Padre Island Convention Center Skylights

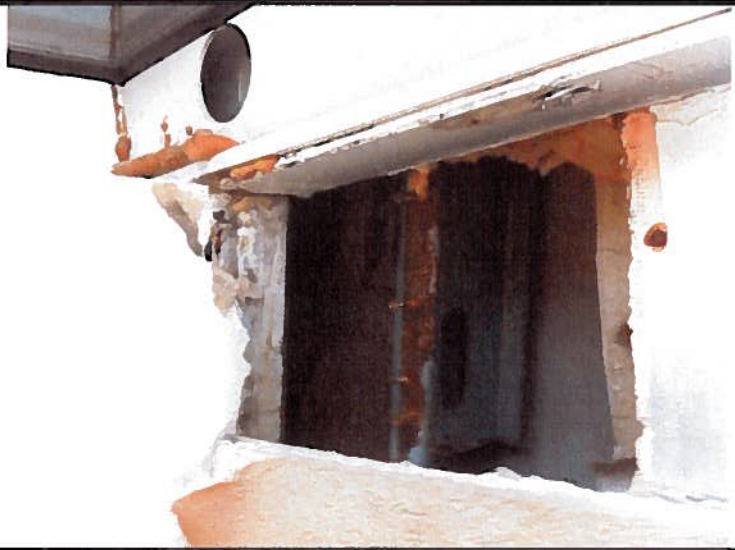
[Photo 04](#)

around and under the East gutter. An area of gypsum wall board had been removed adjacent to this gutter - which exposed the metal studs and the gypsum board on the opposite side of the stud (*Photos 03 & 04*). The studs inside of the wall showed signs of rust and staining was observed internally along the face of the wall board. At the West gutter, rusting structural members were observed, as well as water tracks and sediment.

Damage to the interior of the wall near the gutter for the east Skylight.

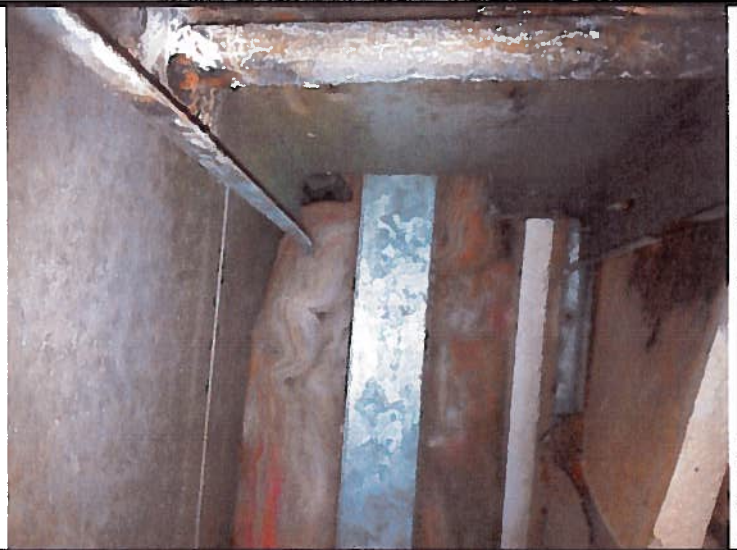
[Photo 05](#)

The integral drainage gutter is blocked by polyurethane foam.

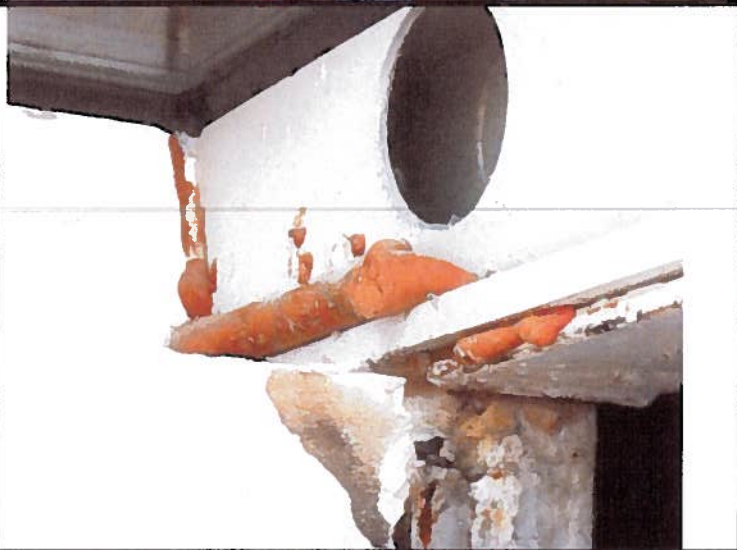
[Photo 06](#)

Along the rake of each skylight, there is evidence that water has breached the glazing seals and has tracked into the frame's gutter system. The gutter system appears to be clear and working properly, except at unsealed butt ends of the skylight frames (where tracks are visible from water that has drained through the gap at the bottom of the integral gutter), and at the base of the East skylight, where polyurethane foam is blocking the integral gutters from discharging into the drainage gutter (*Photos 05*). Corrosion of the underlying steel support structure is visible along the lower joints in the frame's integral Gutters (*Photos 06 & 07*).

The splice is allowing water to contact the underlying steel support and is corroding it.

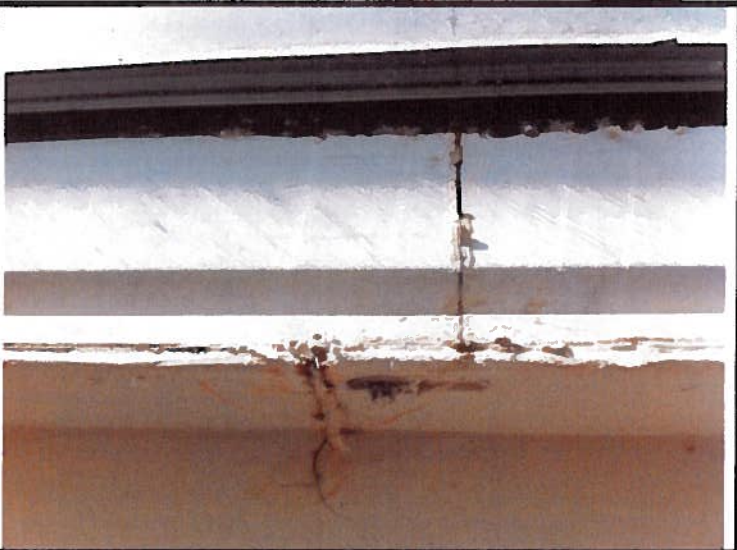
[Photo 07](#)

Water Damage below the East Skylight.

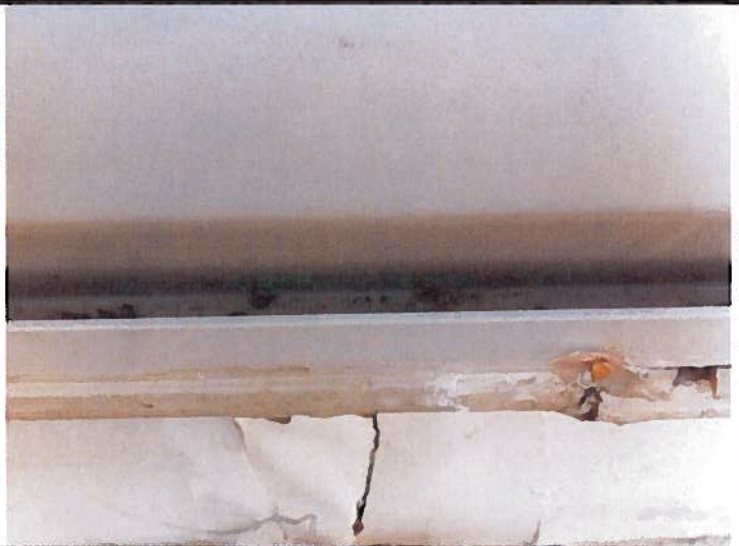
[Photo 08](#)

The internal gutter for the East Skylight appears to be the epicenter for most of the observed damage related to the skylight. A review of the area around the gutter reveals that the gutter collects debris and appears to have backed up from time to time and breached the counterflashing of the gutter box. (*Photos 08 & 09*). Numerous repairs have taken place around the gutter, but none appear to have arrested the water infiltration.

View of the gutter box for the east Skylight. This box collects debris and periodically becomes inundated.

1. Apply a new wet seal at the skylight glazing.
2. Determine if the drain lines from the gutters are obstructed. If they are, clear them.
3. Reseal the gutter to help minimize water infiltration from inundation.

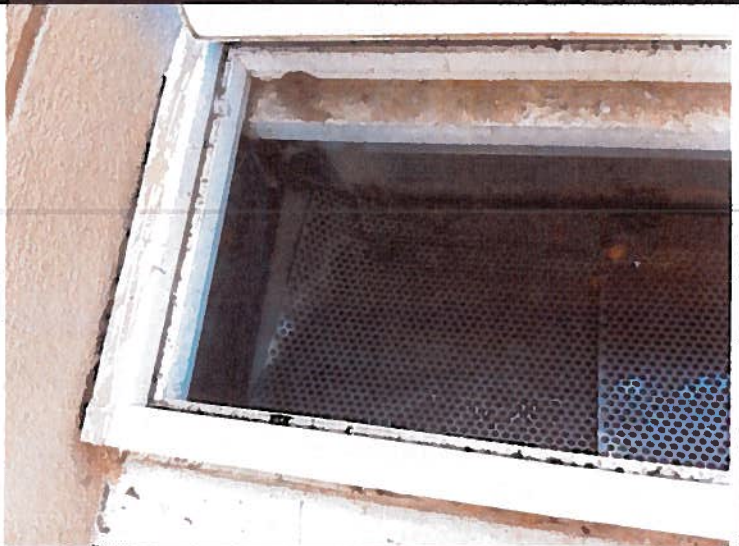
[Photo 09](#)

View of the gutter box for the east Skylight. This box collects debris and periodically becomes inundated.

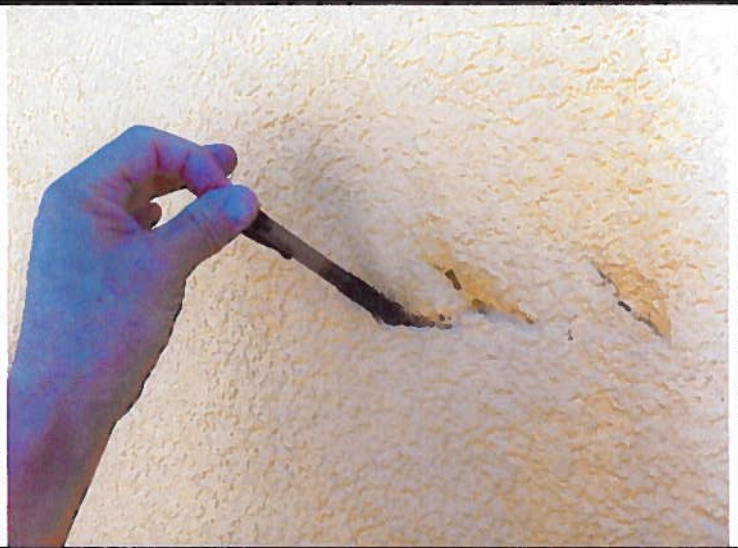
[Photo 11](#)

- Unrepaired breaches caused by debris impact (most likely from Hurricane Dolly) (*Photos 10, 11 & 12*)

A breach in the EIFS caused by debris impact.

1. Repair all wall impact breaches.
2. Install new backer rod and sealant at all panel joints, penetrations and junctions with other materials. Install hoods over all wall penetrations to add an additional level of protection.
3. Properly reinforce and cover all EIFS edges
4. Seal and coat the interior face of the Mechanical Yard Wall.

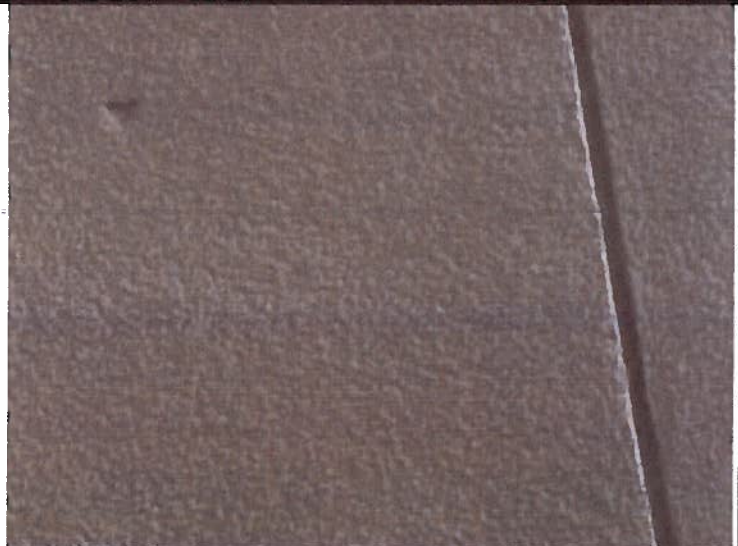
[Photo 12](#)

A chunk of EIFS was removed by debris impact.

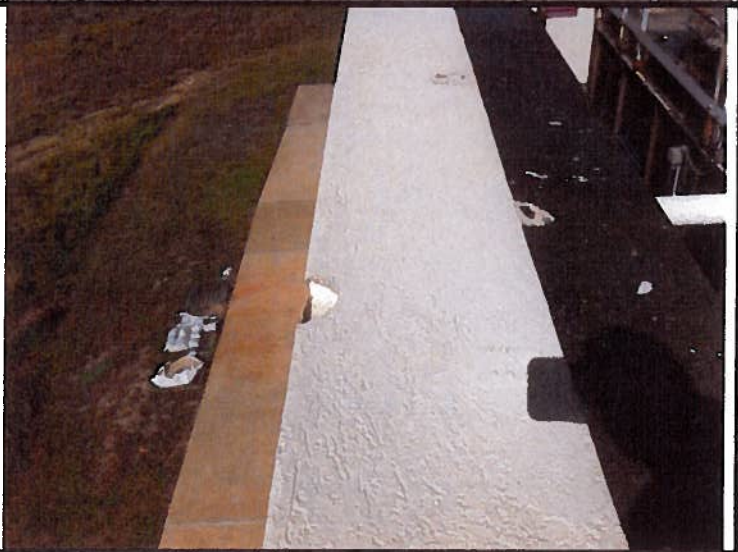
[Photo 13](#)

The EIFS was not properly back wrapped. The underlying insulation is visible.

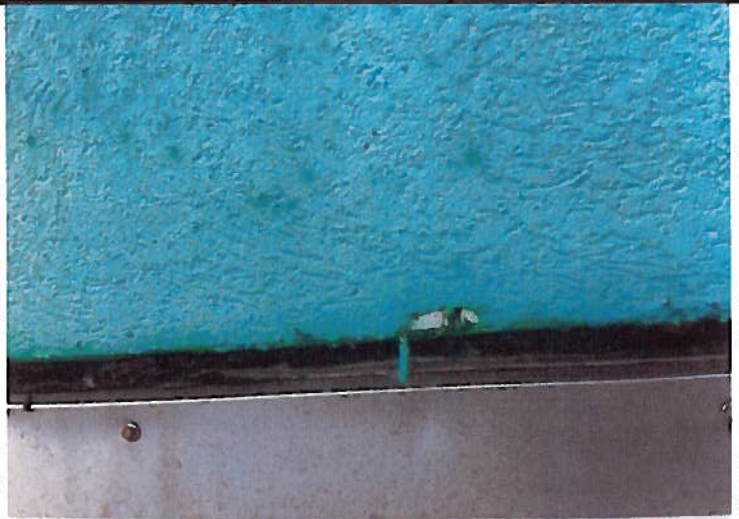
[Photo 14](#)

The edge of the insulation was not properly backwrapped and is exposed. Water that runs down the wall can be drawn into the building along this line.

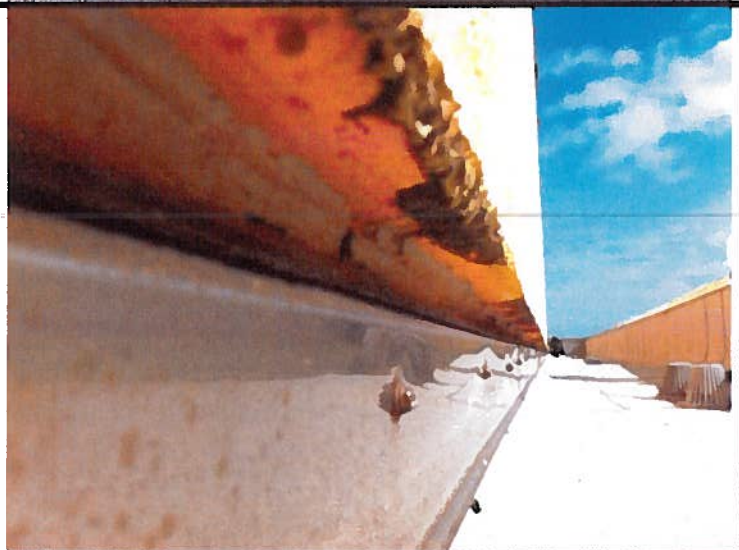
[Photo 15](#)

The edge of the insulation was not properly backwrapped and is exposed. Water that runs down the wall can be drawn into the building along this line.

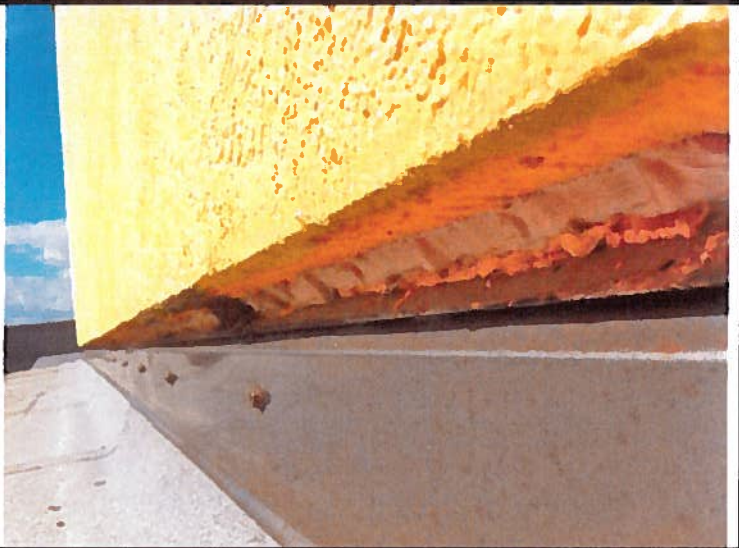
[Photo 16](#)

The edge of the insulation was not properly backwrapped and is exposed. Water that runs down the wall can be drawn into the building along this line.

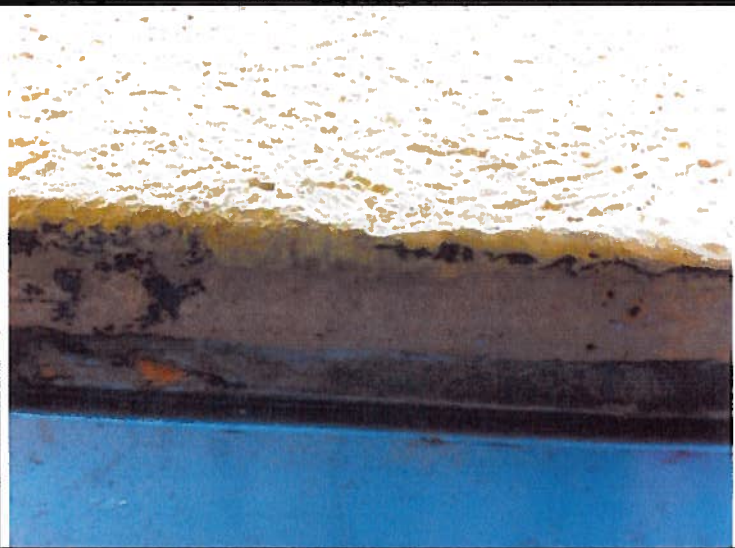
[Photo 17](#)

The sealant joints are failing and are allowing water to infiltrate the EIFS.

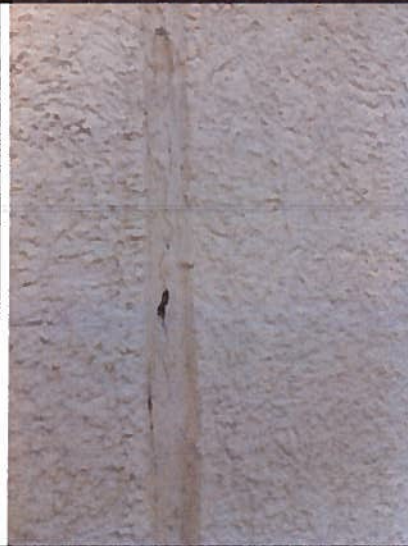
[Photo 18](#)

The sealant joints are failing and are allowing water to infiltrate the EIFS.

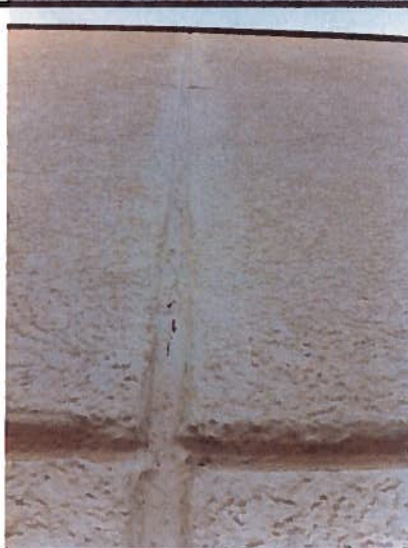
[Photo 19](#)

The sealant joints are failing and are allowing water to infiltrate the EIFS.

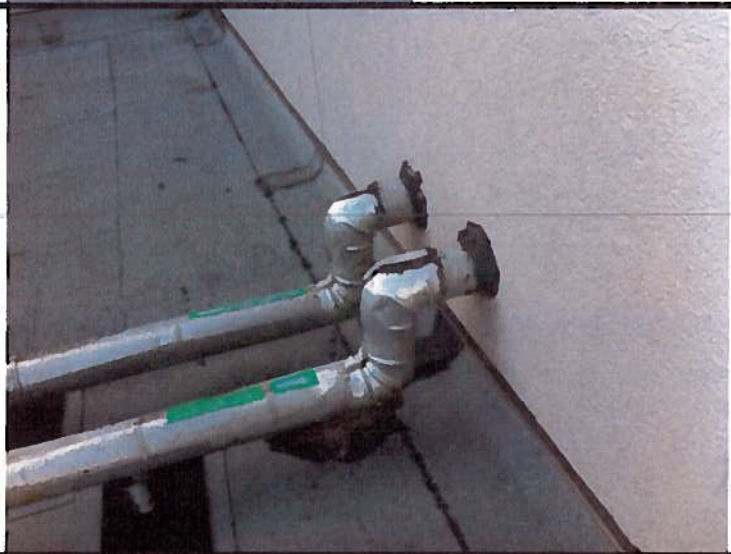
[Photo 21](#)

These pipe penetrations are not properly sealed and are allowing water into the EIFS.

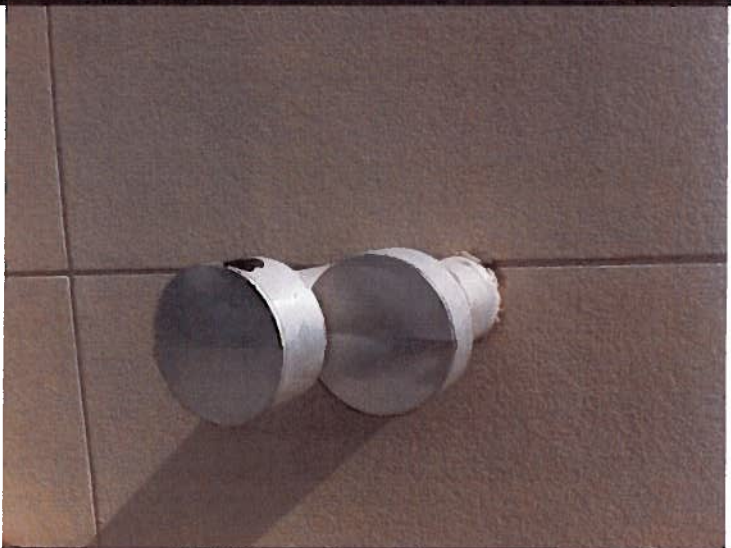
[Photo 22](#)

Because the EIFS system does not employ a Drainage system, water that breaches the surface can not be discharged to the exterior before it enters conditioned space. This condition is resulting in water infiltration at the loading Docks and adding to the water infiltration experienced under the sky lights ([Photos 22 & 23](#)).

The EIFS above the skylight is contributing to the water infiltration that is taking place below the skylight.

1. Remove all "Barrier" system EIFS and replace it with a new EIFS system that incorporates a drainage system with properly flashed transitions at openings, penetrations and with the roof systems.
2. Remove the wall cladding around the Mechanical yard and replace it with a properly designed wall cladding system with properly flashed transitions at openings, penetrations and with the roof systems.

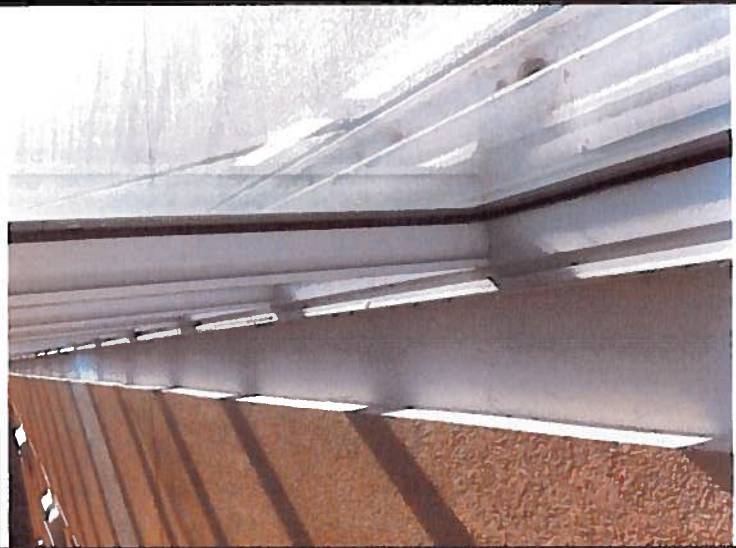
[Photo 23](#)

The EIFS above the skylight is contributing to the water infiltration that is taking place below the skylight.

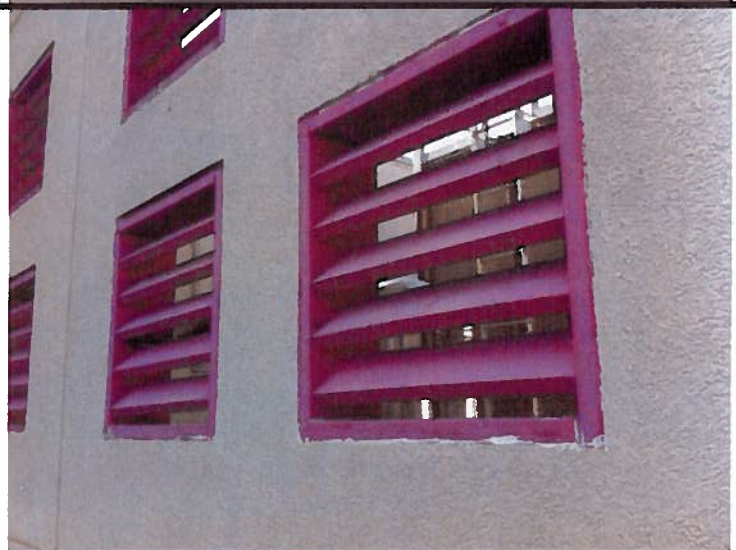
[Photo 25](#)

The Wall surrounding the Cooling tower is has not been designed or installed in a manner that will resist water infiltration. The wall uses wood trim at openings, but joined panels and has improperly flashed penetrations ([Photos 24, 25 & 26](#)). All of these conditions are contributing to the water infiltration being experienced in the area. The roll-up access door at the mechanical yard level is designed in a way that allows water infiltration, as does an access door at ground level adjacent to the East parking lot.

The perimeter of these louvers are not properly sealed and are allowing water into the wall.

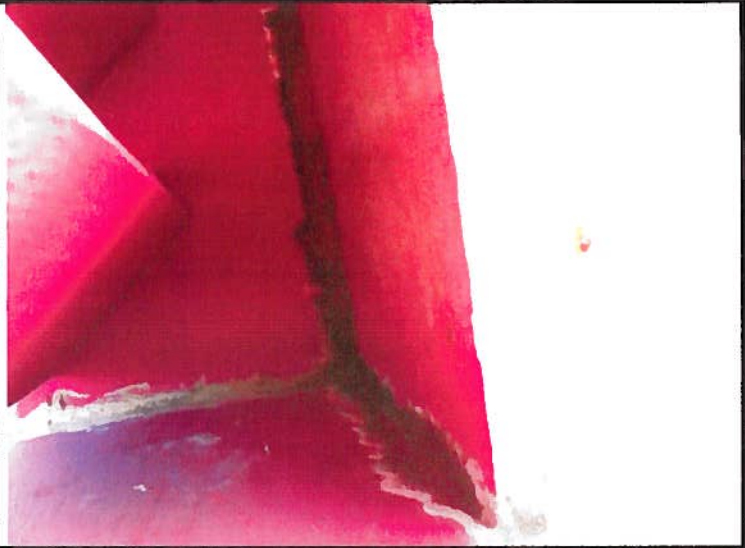
[Photo 26](#)

The wall panels are not properly sealed and are allowing water into the wall.

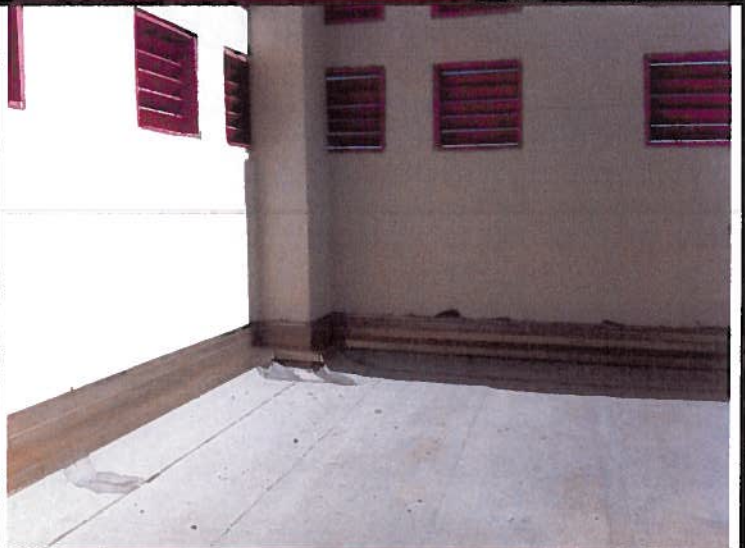
[Photo 27](#)

A blister was observed West of the Exhibit Hall.

1. On a bi-yearly basis, clean all roof debris and inspect all gutters and drain components to insure they are free of debris and unobstructed.
2. Repair the blisters in the roof membrane and drain sumps.
3. On a bi-yearly basis, inspect of for open laps and loose flashings and repair as needed.

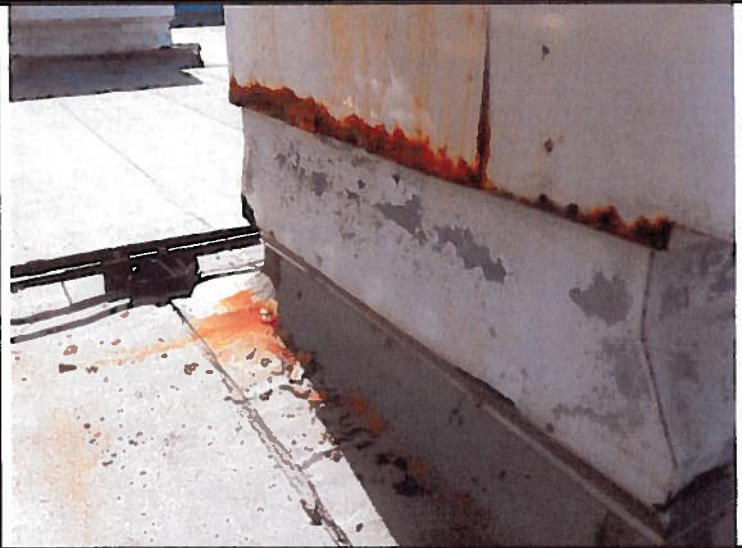
[Photo 29](#)

Corrosion has created a breach over most of the length of this A/C Unit.

1. Repair the breaches in the Equipment housings with sheet metal patches, covered by a reinforced elastomeric coating.
2. Reinstall the Lightning Protection system. Portions of it are currently missing.

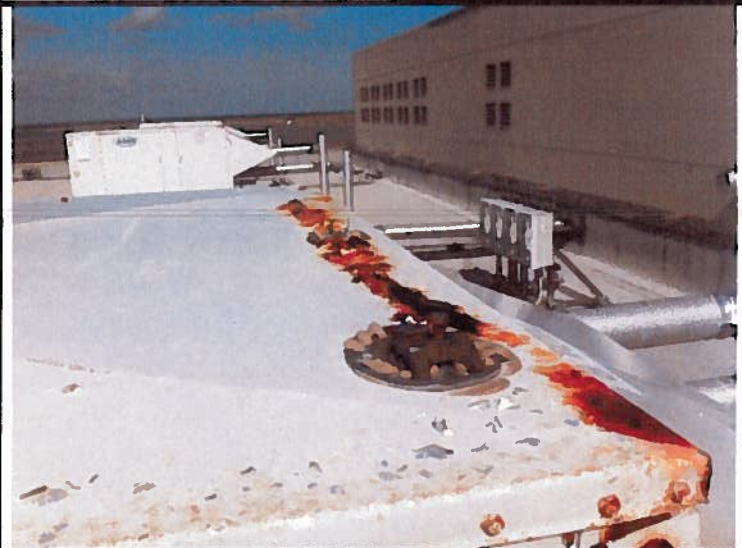
[Photo 30](#)

The roof has several minor deficiencies. A blister was observed above the hallway to the North Meeting rooms ([Photos 29](#)). A water filled blister was observed near the Mechanical yard. ([Photos 30](#)). Several roof drain sumps are wrinkled and have been previously repaired ([Photos 31 & 32](#)).

A water blister was observed in this corner near the mechanical yard.

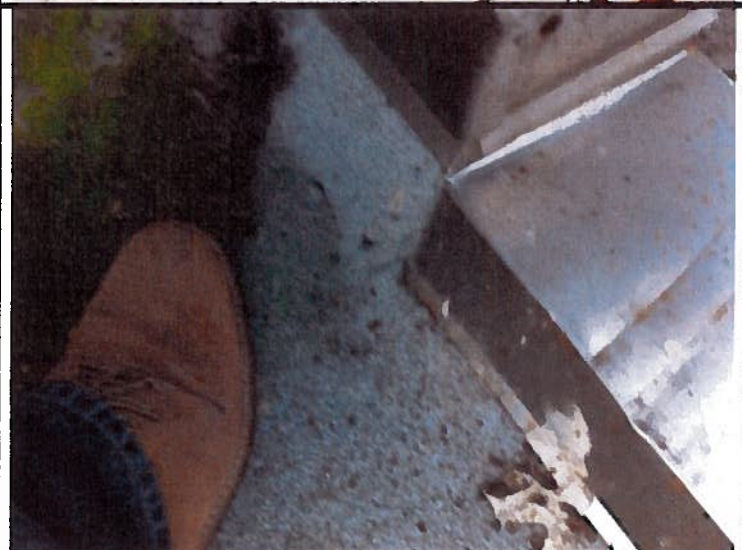
[Photo 31](#)

Many of the drain sumps are wrinkled.

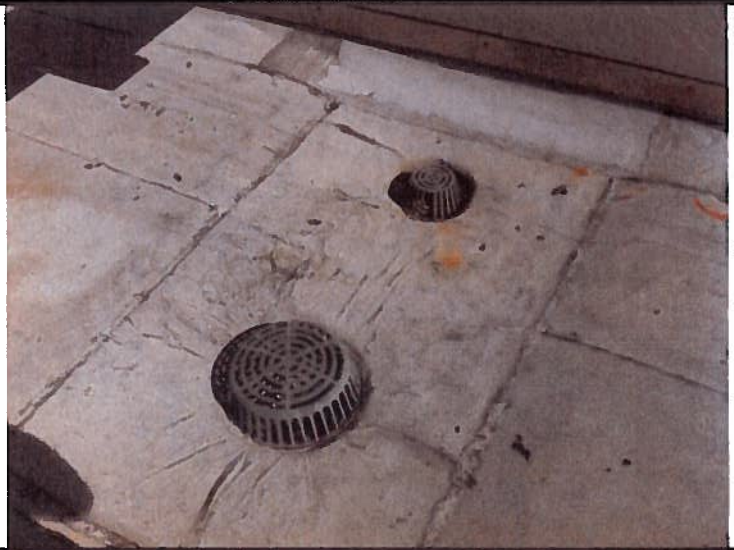
[Photo 32](#)

Repairs have been attempted on this drain, but have not been successful.

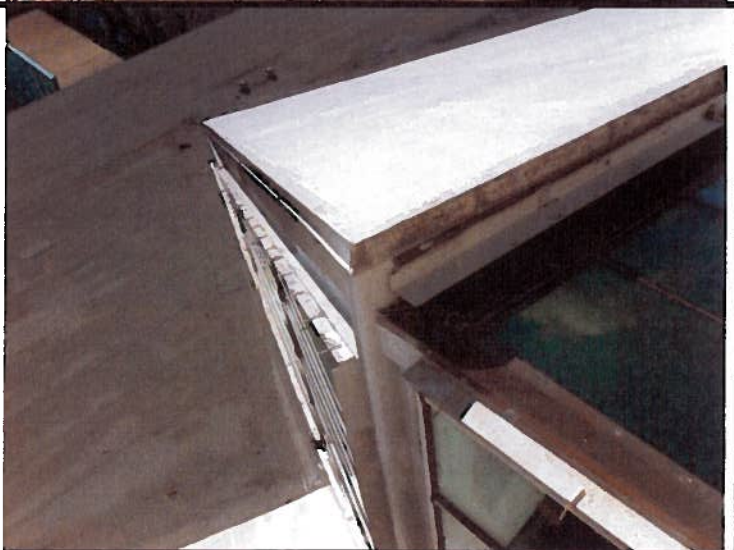
[Photo 34](#)

The glazing strips of the skylights are now over 20 years old. Over time they lose their elasticity, become brittle and fail to maintain a seal. A wet seal is usually applied to the glass units from the top to provide a "perfect seal" for the system. It could not be verified how old the sealant is, but assuming that the sealant and glazing strips are from the original construction, based on typical life expectancies, both are nearing or at the end of their useful life expectancy.

The glazing strips and sealant on the skylights is aging and resulting in breaches.

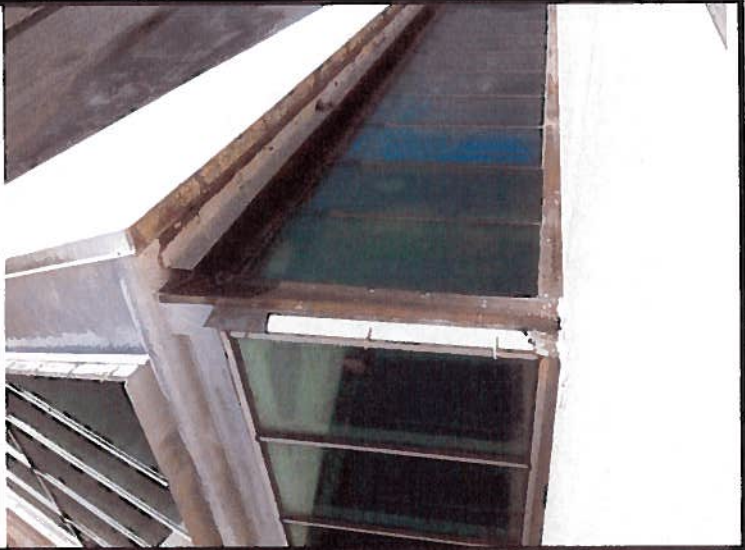
[Photo 35](#)

Water that flows to this gutter sometimes inundates the gutter and results in water infiltration.

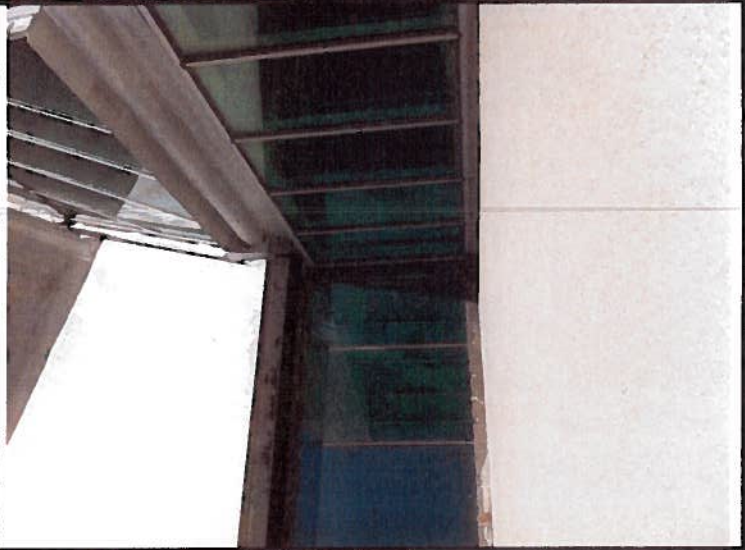
[Photo 36](#)

The glazing strips and sealant on the skylights is aging and resulting in breaches.
