# LIMITED BUILDING ENCLOSURE ASSESSMENT

**South Padre Island Convention Centre  
South Padre Island, Texas**

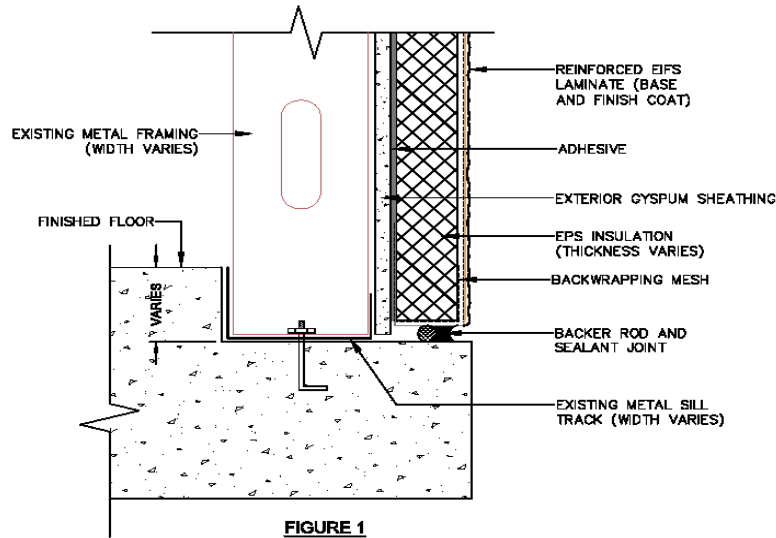
## 2.2 Fenestration Systems

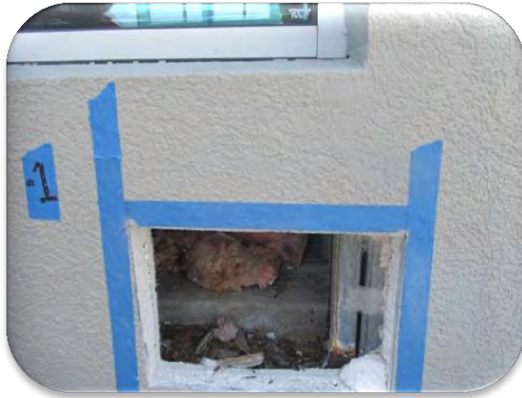
Location: East Elevation adjacent to Room 311 – Opening measured approximately 15” wide x 11” high extracted at the base of the wall and was directly under the corner of a window.

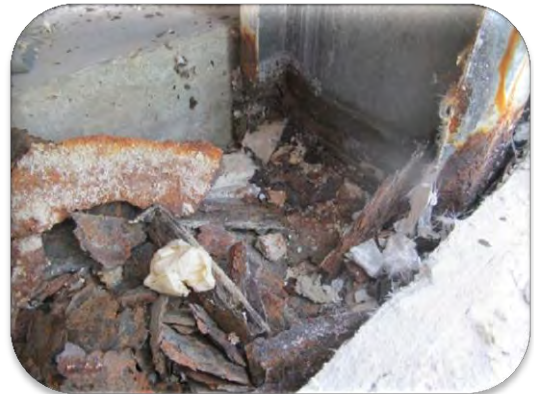
- The EIFS coating appeared to be in generally good condition overall with no observable defects.
- Exposed mesh along bottom of EIFS termination due to missing base coat applications.
- Extensive metal sill track corrosion with total member loss.
- Corrosion on vertical galvanized steel framing members (studs), which extended approximately 2” to 4” upwards.
- Evidence of rust stains on vertical framing members and sheathing underneath window.
- Corrosion on horizontal sill track directly beneath window.
- Deteriorated sealant along the base of the EIFS termination.

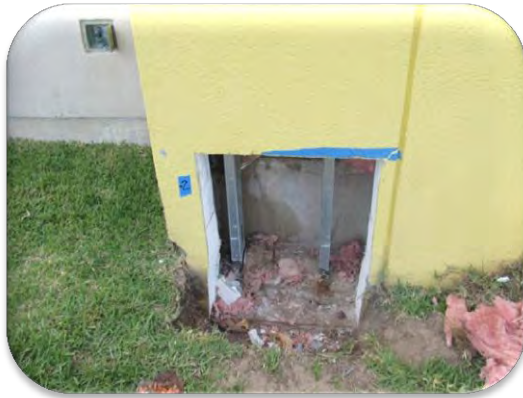
Location: East Elevation adjacent to Room 600 (Exhibit Hall) – Opening measured approximately 19-1/2" wide x 25-1/2" high and was extracted at the southeast corner.

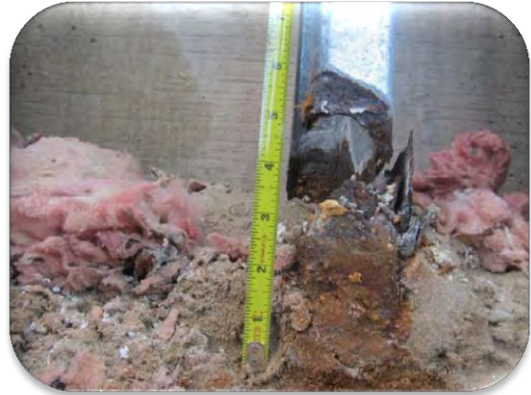
- The EIFS system extended approximately 12" below grade.
- Exposed mesh along bottom of EIFS termination due to missing base coat applications.
- Extensive metal sill track corrosion with total member loss.
- Corrosion on vertical galvanized steel framing members (studs), which extended approximately 6" upwards.
- Dampness on horizontal framing members and sheathing within cavity at corner.
- Tunnels in the EPS insulation indicative of insect infestation.
- Deteriorated sealant along the base of the EIFS termination.

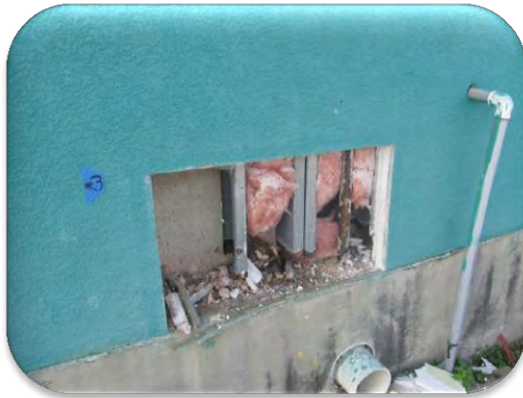
Location: North Elevation adjacent to Room 602 (Exhibit Hall) – Opening measured approximately 32” wide x 19” high extracted at the base of the wall. Two windows were located over the opening.

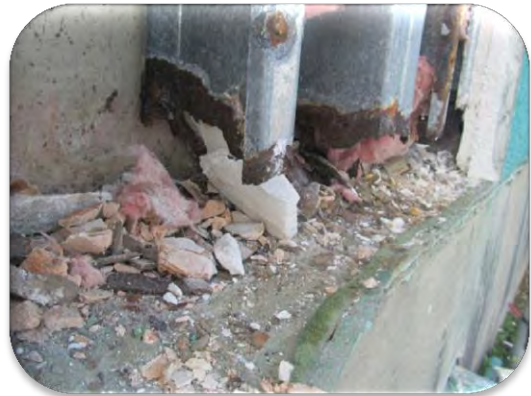
- The EIFS coating appeared to be in generally good condition overall with no observable defects.
- Exposed mesh along bottom of EIFS termination due to missing base coat applications.
- Extensive metal sill track corrosion with total member loss.
- Corrosion on vertical galvanized steel framing members (studs), which extended approximately 2” to 4” upwards, with the exception of one framing member that exhibited rust extending upwards past the height of the opening.
- Deteriorated sealant along the base of the EIFS termination.

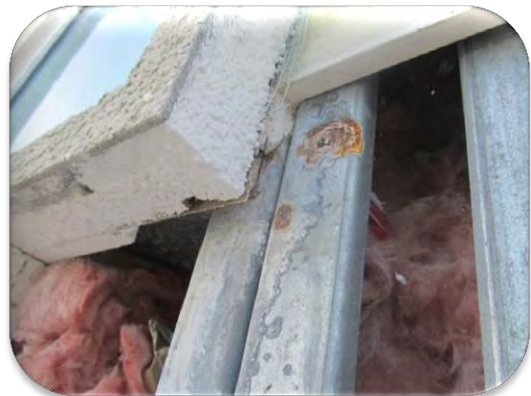
- The EIFS coating appeared to be in generally good condition overall with no observable defects.
- Slight corrosion was observed at a fastener penetration along a vertical framing member.
- Corrosion on bottom of horizontal metal sill underneath window.

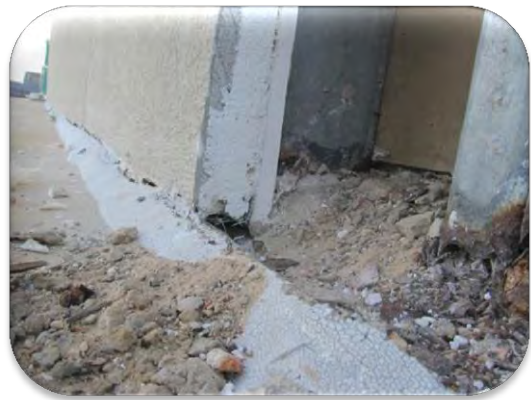
- The EIFS coating appeared to be in generally good condition overall with no observable defects.
- Exposed mesh along bottom of EIFS termination due to missing base coat applications.
- Tunnels in the EPS insulation indicative of insect infestation.
- Extensive metal sill track corrosion with total member loss.
- Corrosion on vertical galvanized steel framing members (studs), which extended approximately 2” to 4” upwards.
- Deteriorated sealant along the base of the EIFS termination.

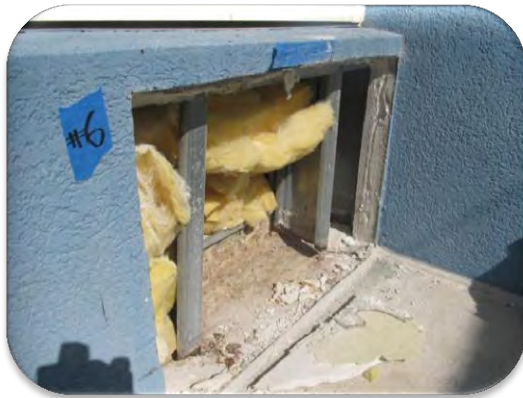
Location: West Elevation adjacent to Meeting Room 102 – Opening measured approximately 24” wide x 18” high extracted at the base of the wall underneath the corner of a window.

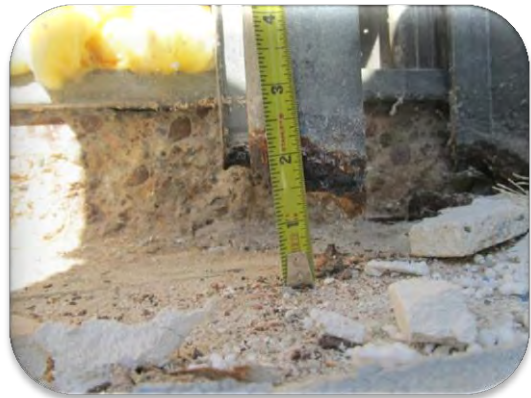
- The EIFS coating appeared to be in generally good condition overall with no observable defects.
- Exposed mesh along bottom of EIFS termination due to missing base coat applications.
- Extensive metal sill track corrosion with total member loss.
- Corrosion on vertical galvanized steel framing members (studs), which extended approximately 2” upwards.
- Deteriorated sealant along the base of the EIFS termination.

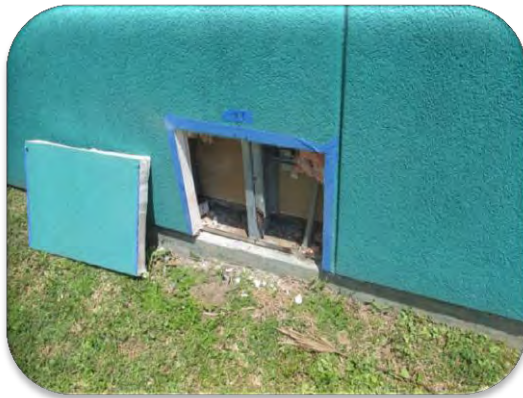
Location: East Elevation on South side adjacent to Room 602 (Green Room) – Opening measured approximately 24” wide x 20” high extracted at the base of the wall underneath the corner of a window.

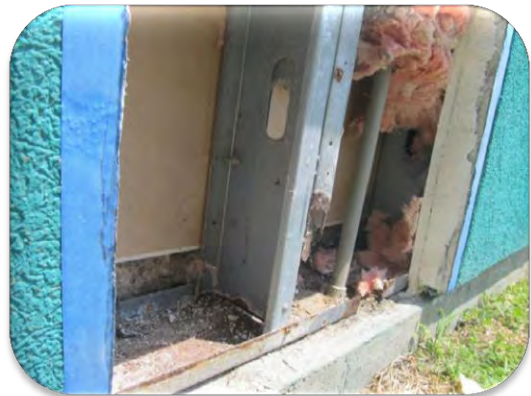
### 3.3 Interior Wall Openings

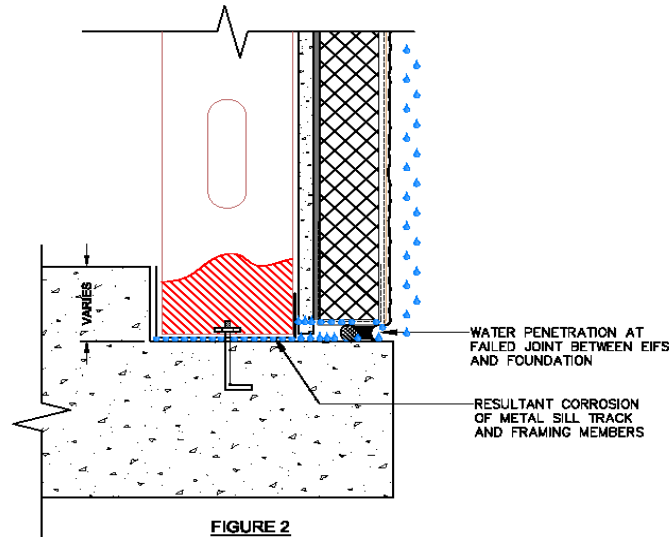
The water penetration is believed to have been on-going for a long period of time and appears to have led to significant widespread corrosion of the metal sill track and framing members within the wall assembly. This was consistently observed from interior access panels and exterior DTO's. The corrosion has most likely been accelerated due to the coastal environment.

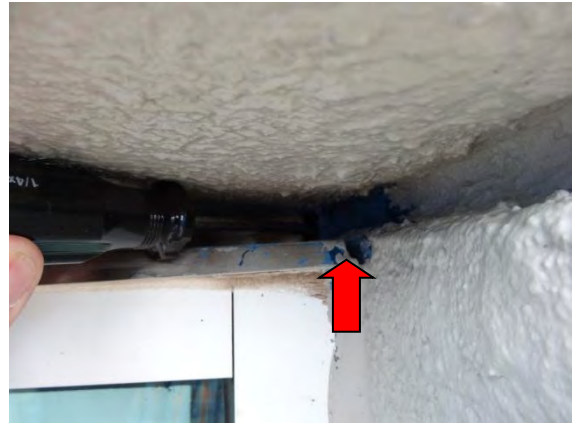
**Photo #4** Detail view of opening at corner of window, typical condition.

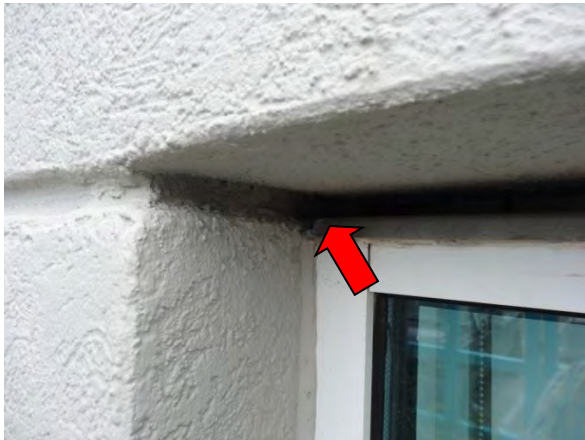
**Photo #5** Opening at window corner, typical condition.

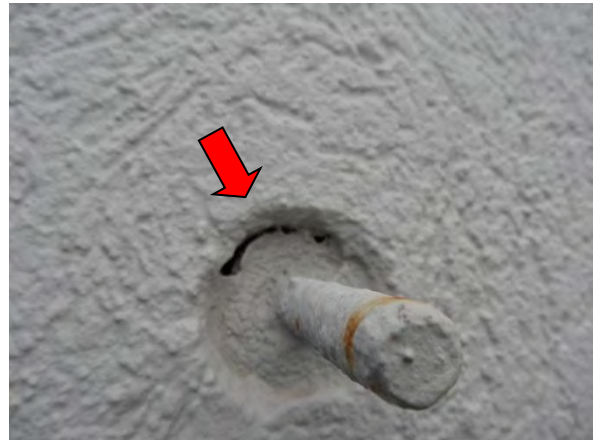
**Photo #6** Opening at penetration above windows, typical condition.

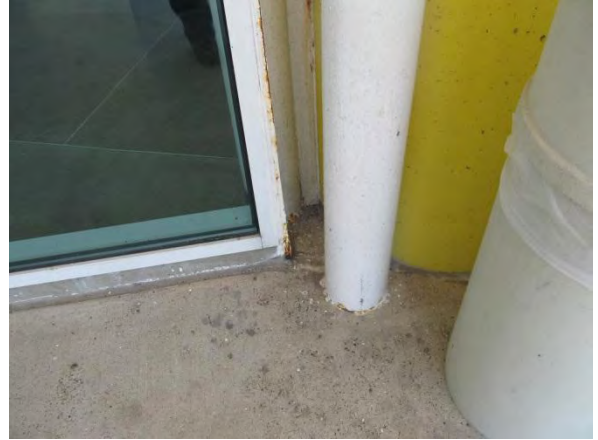
**Photo #8** Deteriorated sealant joint along bottom of window frame and localized corrosion on framing members.

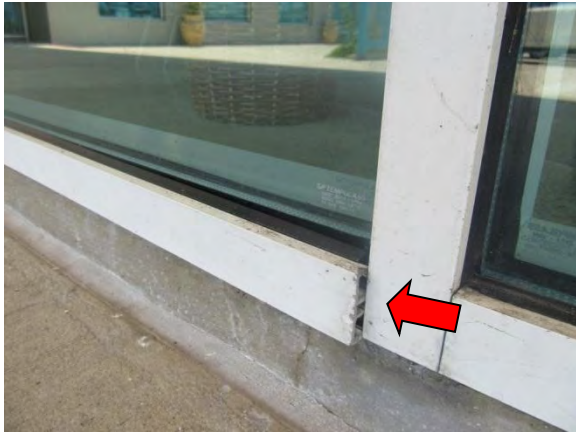
**Photo #9** Displaced window framing member.

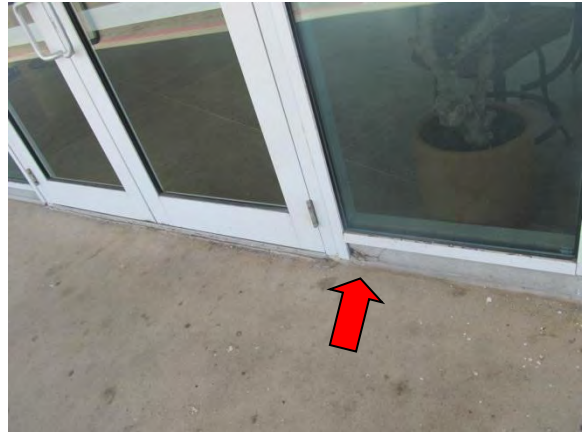
**Photo #10** Spalled concrete near door.

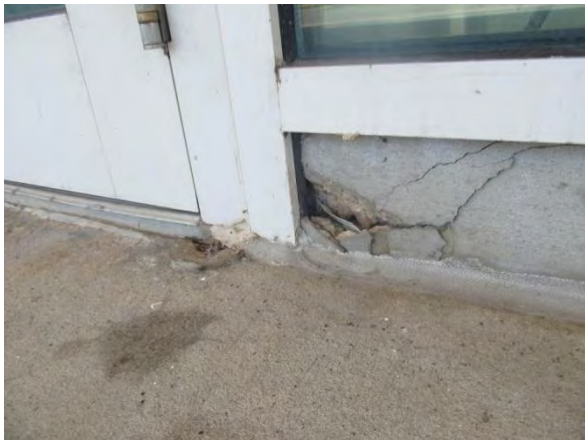
**Photo #11** Detail view of spalled concrete near door referenced in previous photograph.

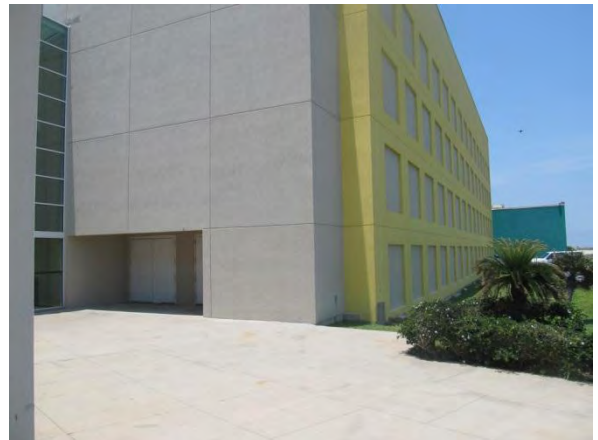
**Photo #12** East elevation facing north. Entrance to Room 600.

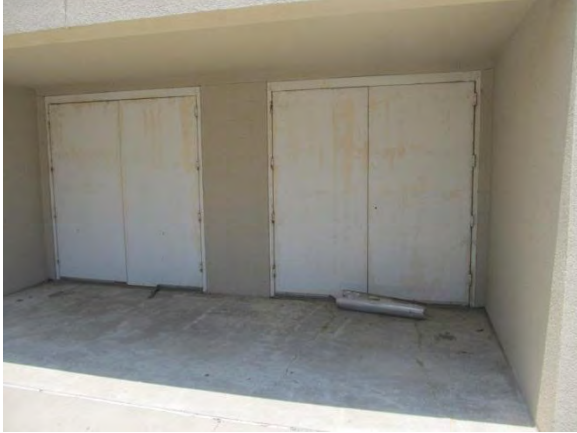
**Photo #13** Entrance doors to Room 600. Facility personnel reported active water leaks under thresholds.

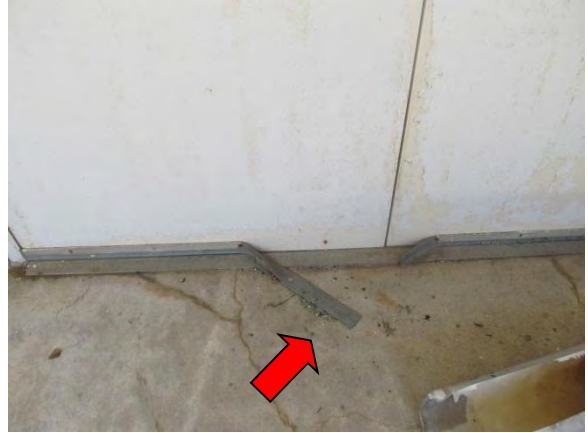
**Photo #14** Detail view of damaged threshold and door sweeps.

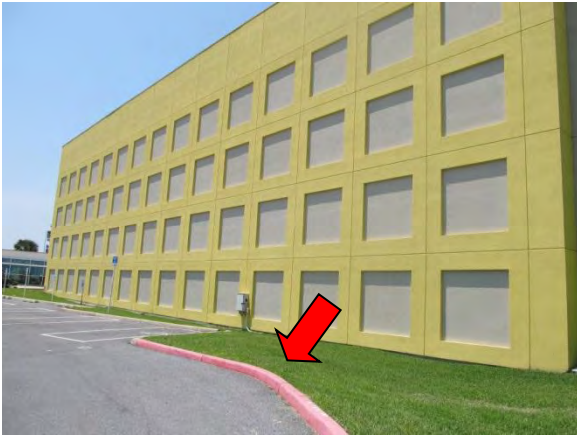
**Photo #15** East elevation facing southwest.

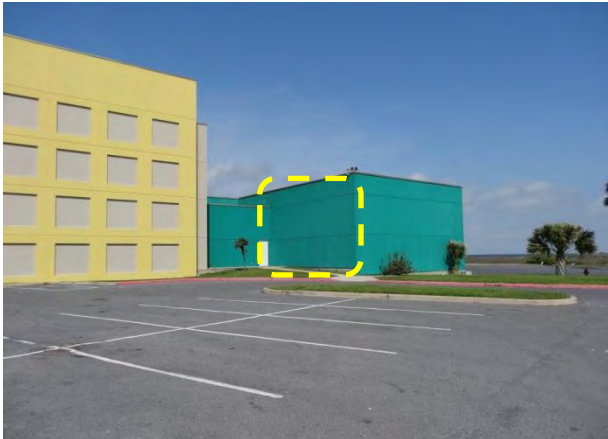
**Photo #18** Green room (602) where highlighted portion of wall was reportedly blown out during Hurricane Dolly and replaced.

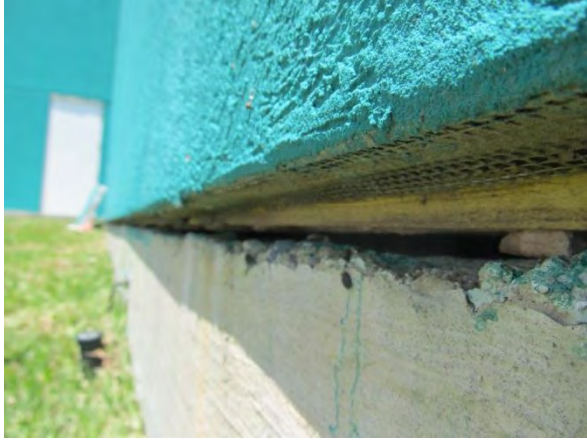
**Photo #19** Exposed backwrapping and exterior sheathing at bottom of EIFS wall due to missing sealant and backer rod joint along south wall of Green Room.

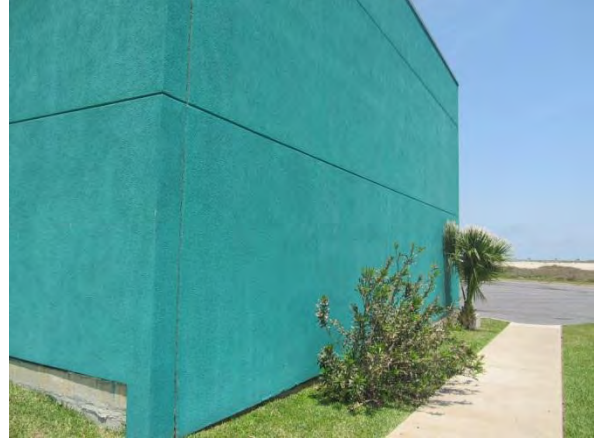
**Photo #20** East elevation of Green Room facing north.

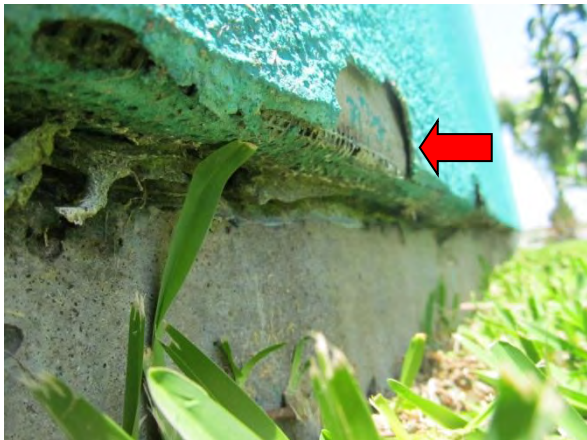
**Photo #23** Exposed backwrapping along bottom of EIFS wall. Note spalled EIFS finish coat.

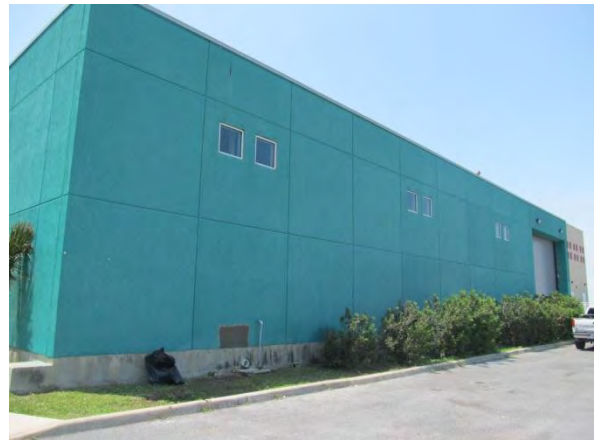
**Photo #24** North elevation.

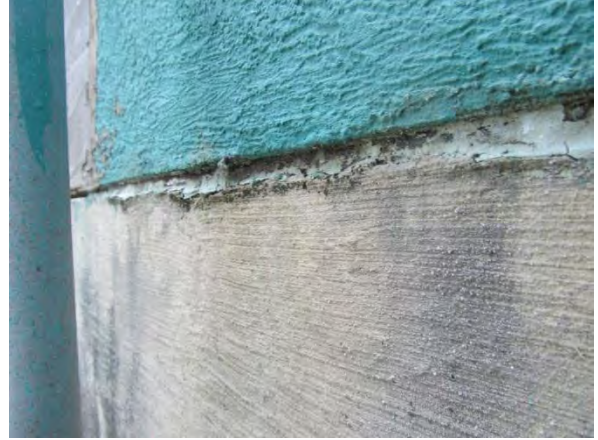
**Photo #26** Joint between EIFS and foundation.

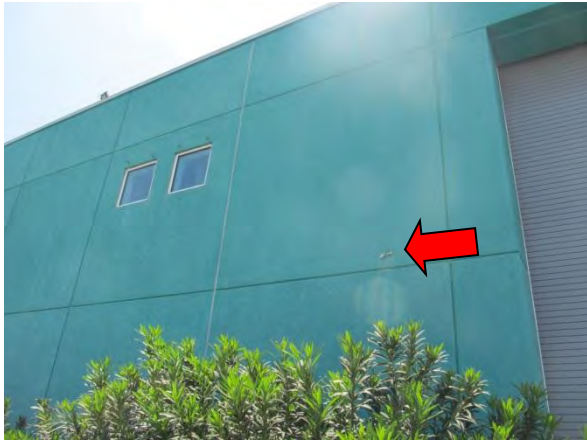
**Photo #27** North elevation. Displaced/damaged wall penetration exposing EIFS reinforcement.

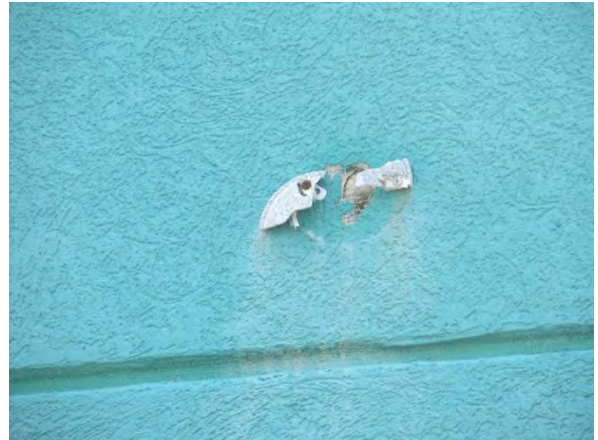
**Photo #28** Detail view of damaged referenced in previous photograph.

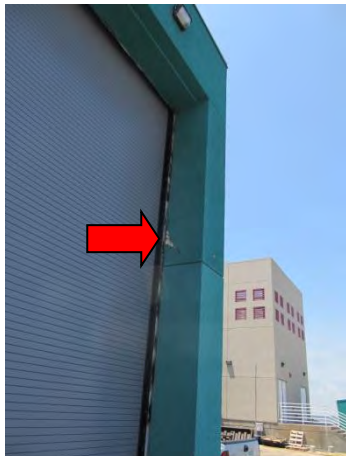
**Photo #29** Damaged EIFS near overhead door.

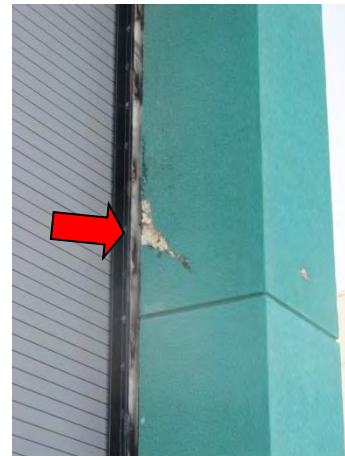
**Photo #30** Detail view of damaged EIFS.

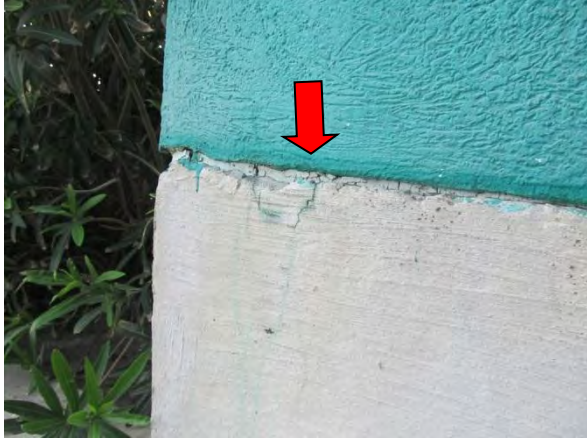
**Photo #31** Deteriorated sealant between EIFS termination and foundation, typical condition throughout.

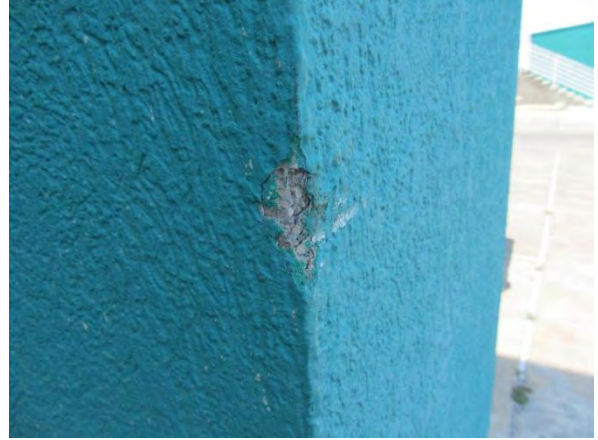
**Photo #32** Damaged EIFS at corner of building.

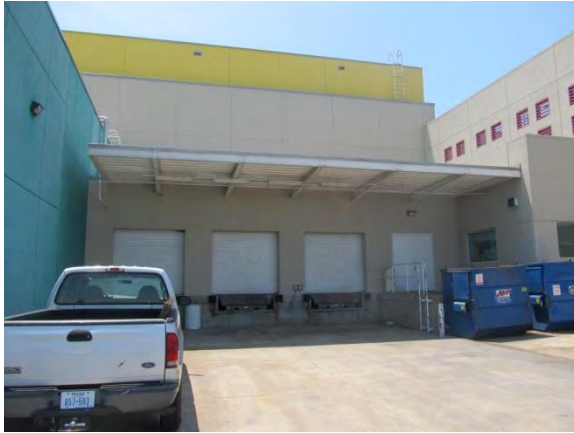
**Photo #33** Receiving area along north side of facility.

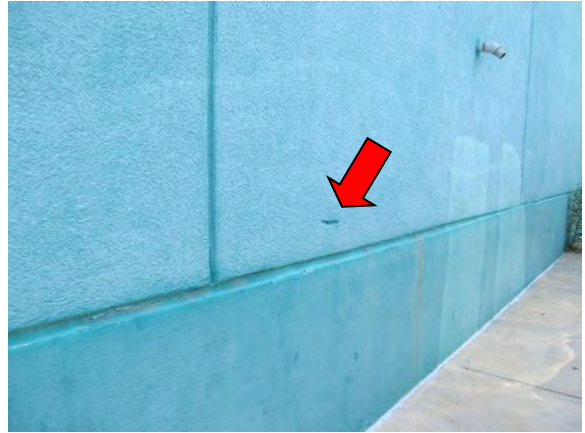
**Photo #34** Damaged EIFS adjacent to Receiving area.

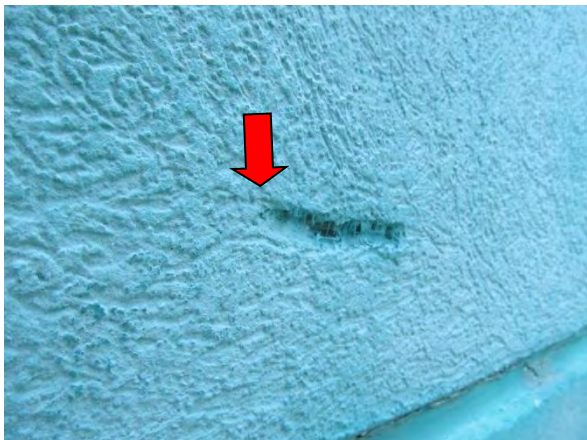
**Photo #35** Detail view of damaged EIFS referenced in previous photograph.

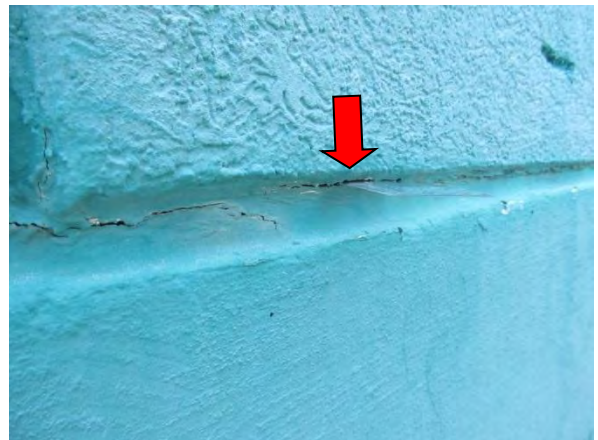
**Photo #36** Sealant adhesion failure along EIFS termination, typical condition throughout.

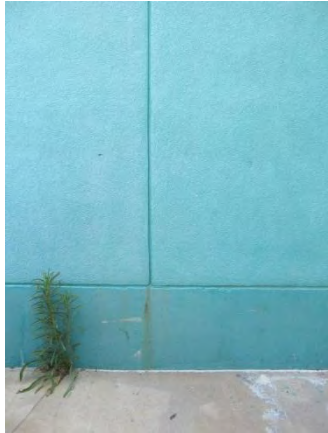
**Photo #37** Staining at EIFS joint.

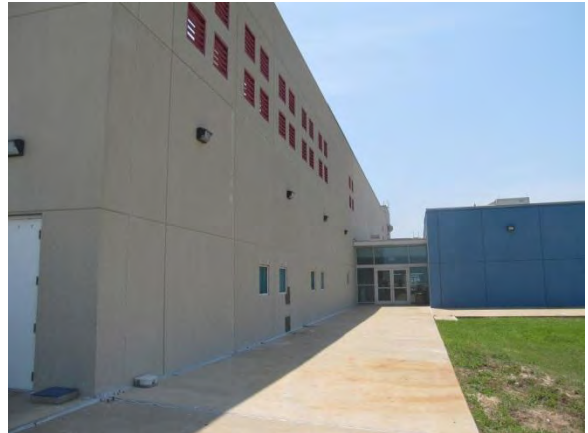
**Photo #38** Northwest elevation facing south.

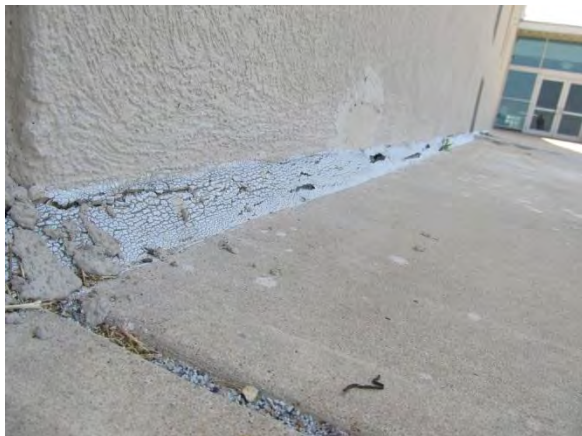
**Photo #39** Deteriorated and weathered sealant joint at bottom of EIFS wall, typical condition throughout.

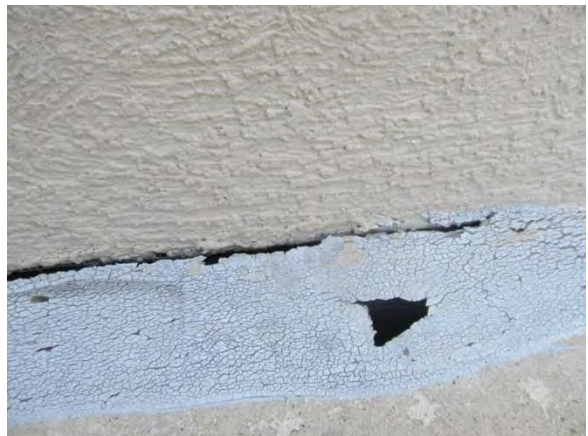
**Photo #40** Detail view of typical deterioration and sealant adhesion failure at bottom of EIFS wall.

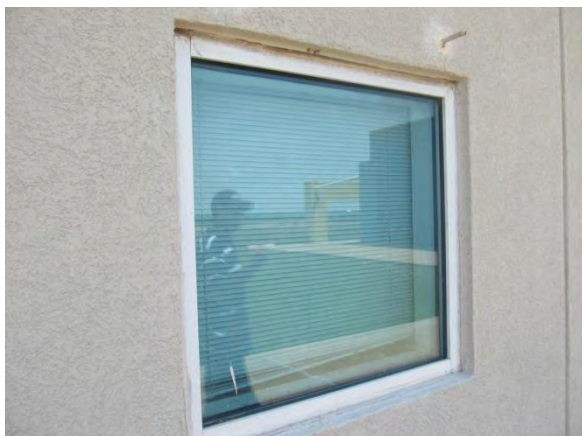
**Photo #41** Typical "punch" window adjacent to Room 408.

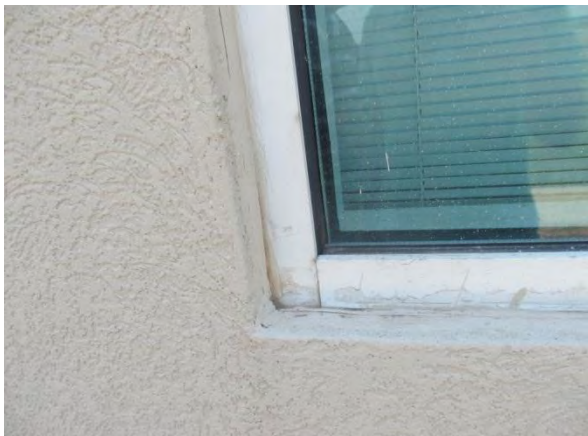
**Photo #42** Sealant repairs and/or replacement along window perimeter.

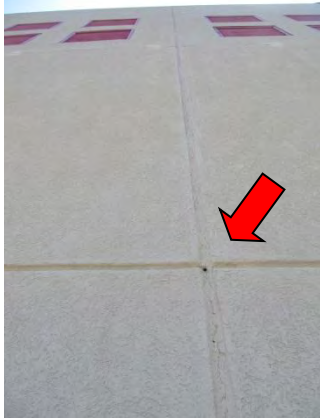
**Photo #43** Deteriorated vertical control joint sealant at EIFS wall.

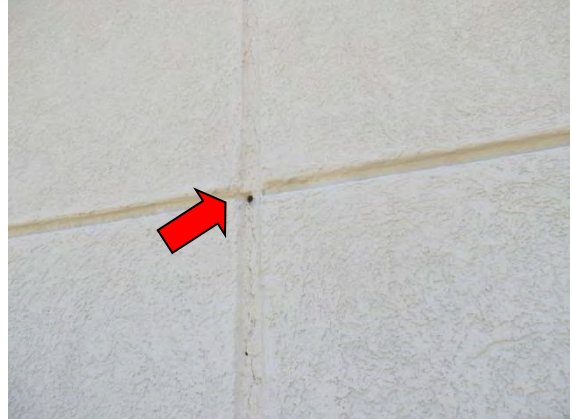
**Photo #44** Detail view of hole in sealant and sealant cohesion failure in at EIFS wall.

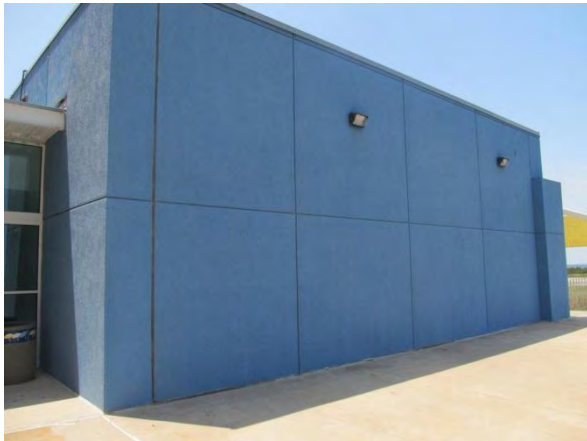
**Photo #45** North elevation, Room 203.

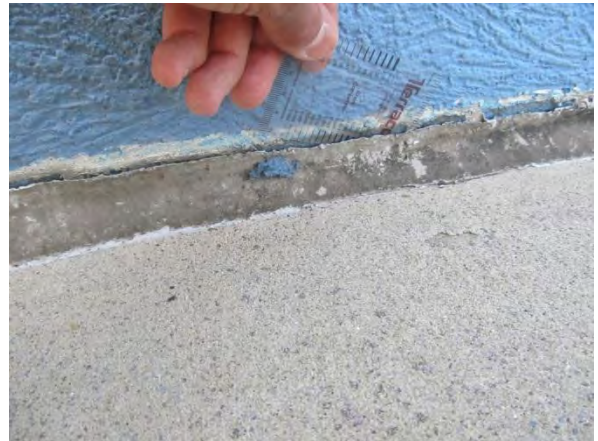
**Photo #46** Typical sealant adhesion failure along bottom of EIFS wall termination.

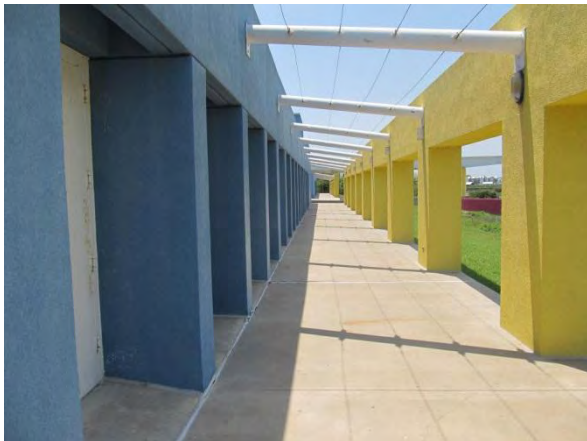
**Photo #47** Overview of west elevation facing south.

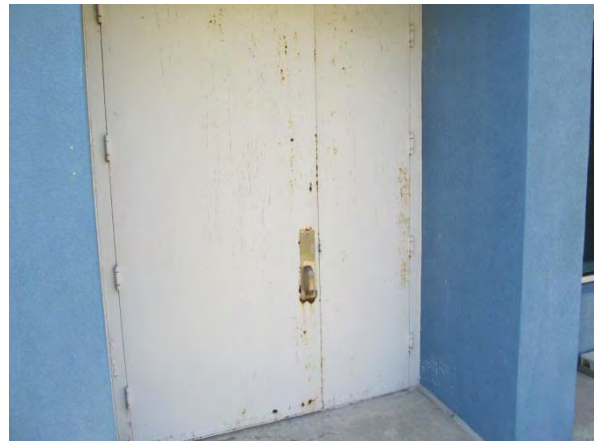
**Photo #48** Typical rust on service doors.

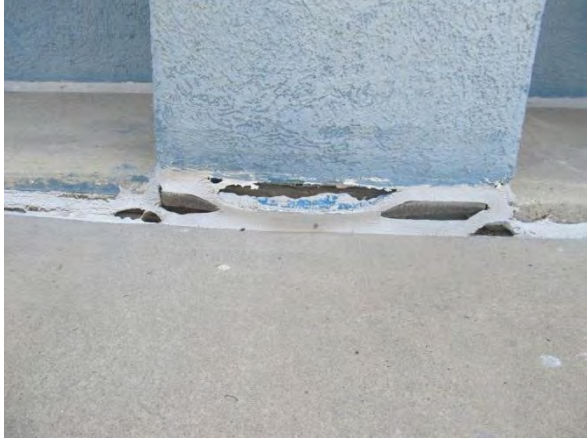
**Photo #49** Sealant failure at bottom of EIFS termination, typical condition.

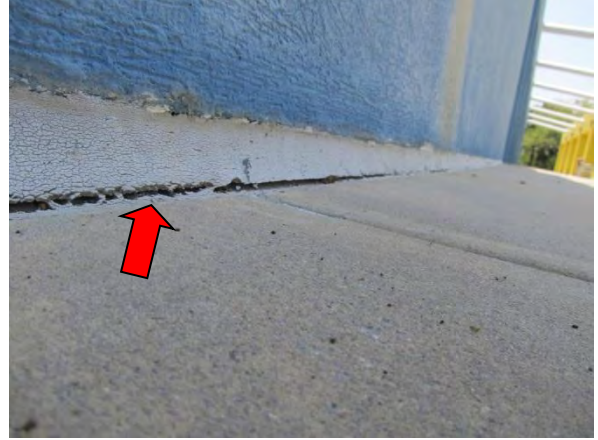
**Photo #50** Sealant adhesion failure along bottom of EIFS termination, typical condition throughout.

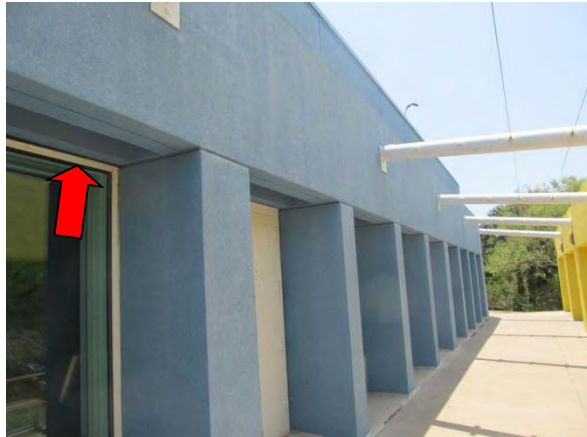
**Photo #51** Openings along window heads are unsealed.

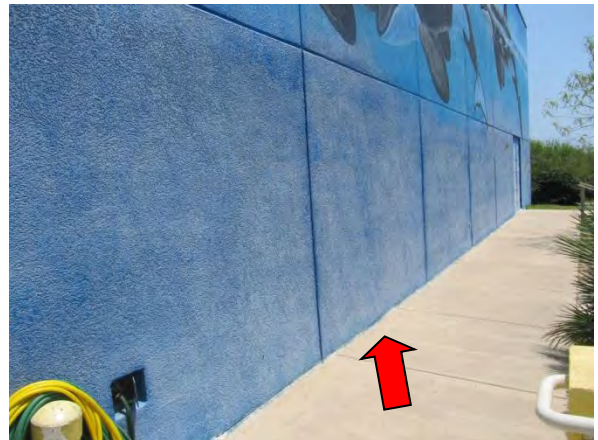
**Photo #54** Deteriorated sealant at bottom of EIFS wall.

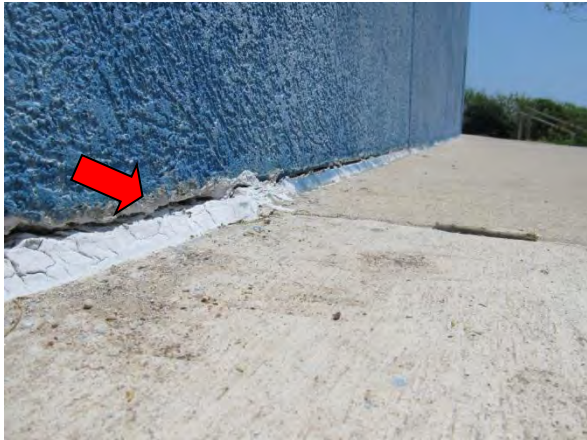
**Photo #55** Sealant adhesion failure at bottom of EIFS wall, typical condition throughout.

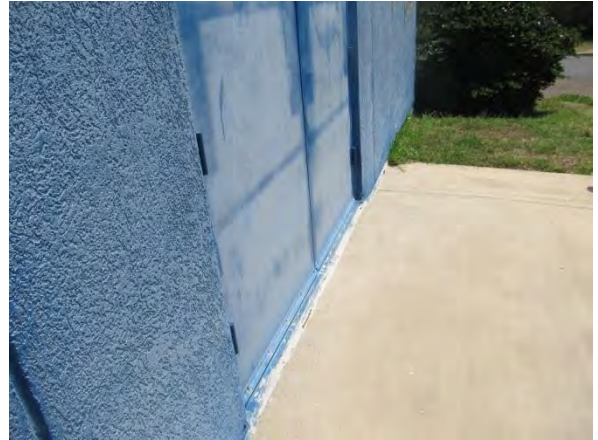
**Photo #56** Typical deteriorated and weathered sealant at bottom of doors.

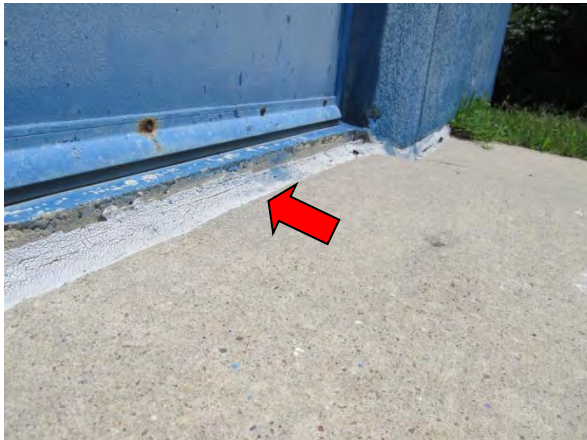
**Photo #57** Detail view of deteriorated sealant referenced in previous photograph.

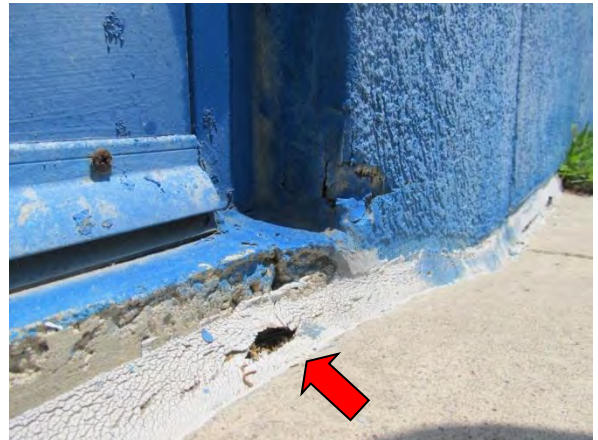
**Photo #58** Hole in sealant. Also note damaged EIFS at corner.

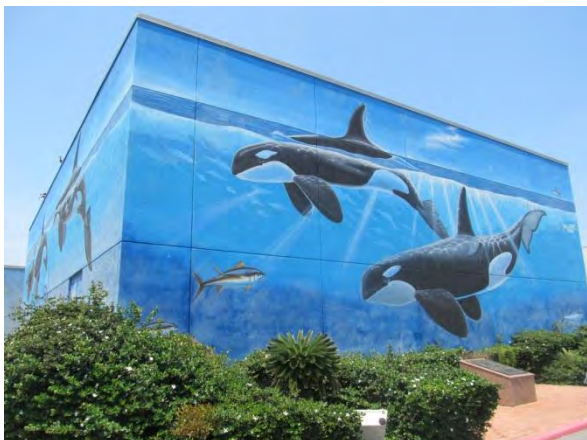
**Photo #59** East "WyLand" wall.

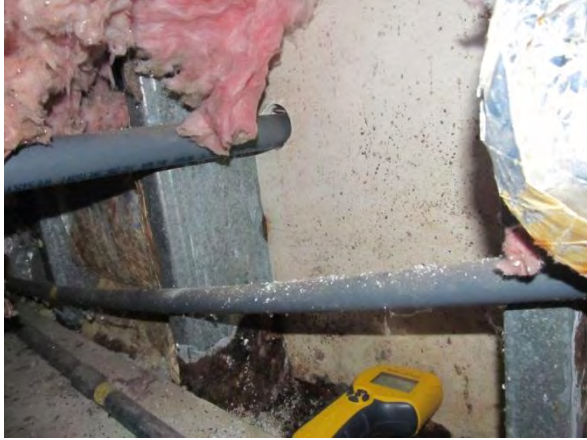
**Photo #61** Interior view of conduit penetration from electrical box. Water was observed migrating through opening during water spray testing.

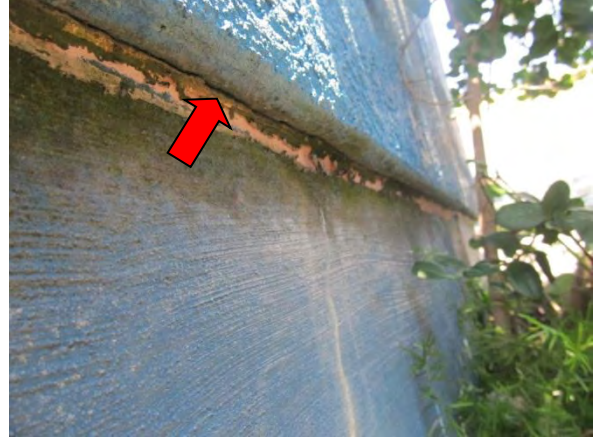
**Photo #62** Sealant adhesion failure along bottom of EIFS termination, typical condition. Also note staining on sealant.

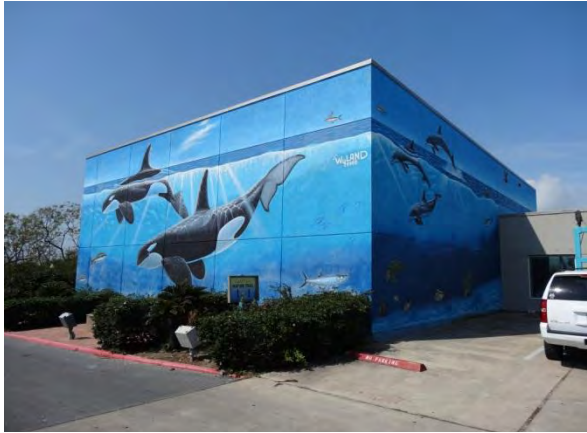
**Photo #63** Overview of east elevation of "WyLand" wall facing southwest.

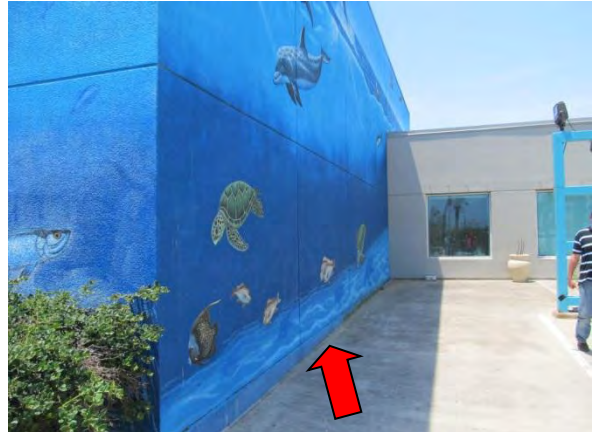
**Photo #64** Sealant deterioration along north "WyLand" wall, typical condition.

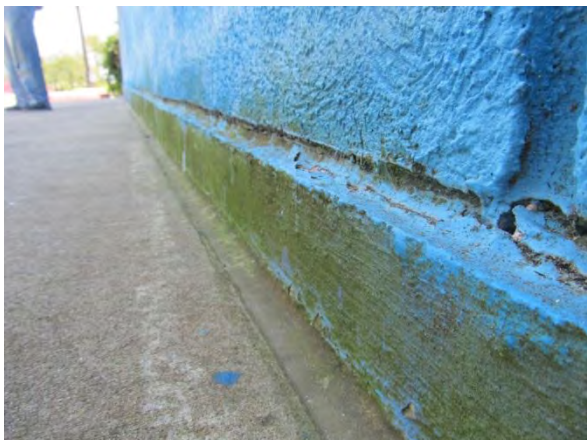
**Photo #65** Detail view of sealant deterioration along bottom of EIFS wall.

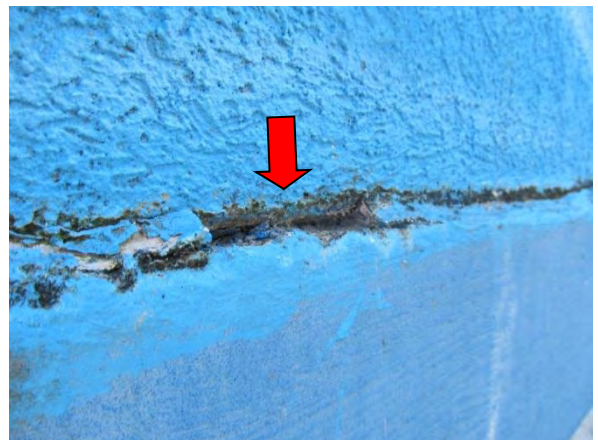
**Photo #66** Detail view of typical sealant deterioration along bottom of EIFS wall.

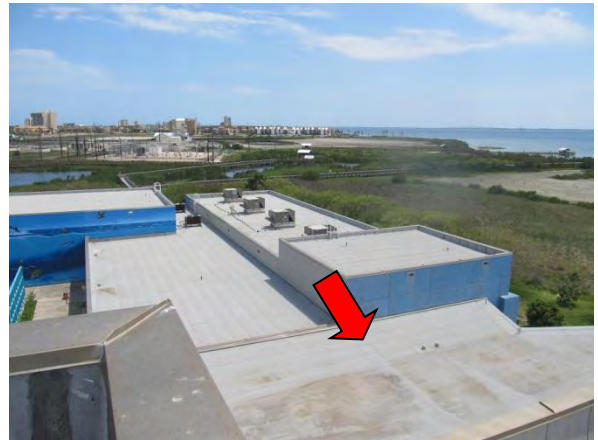
**Photo #68** Overview of roof areas facing south. Note staining on lower roof over lobby.

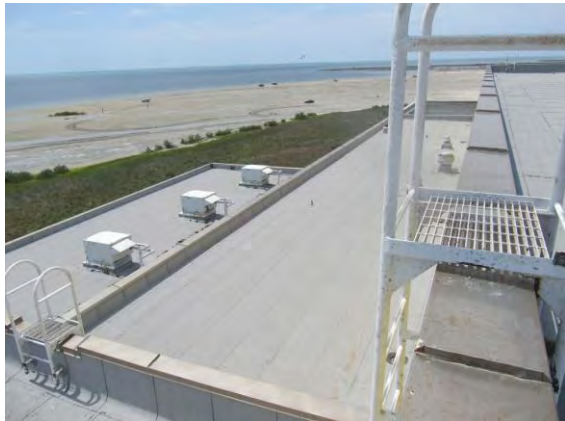
**Photo #69** Overview of roof areas facing north.

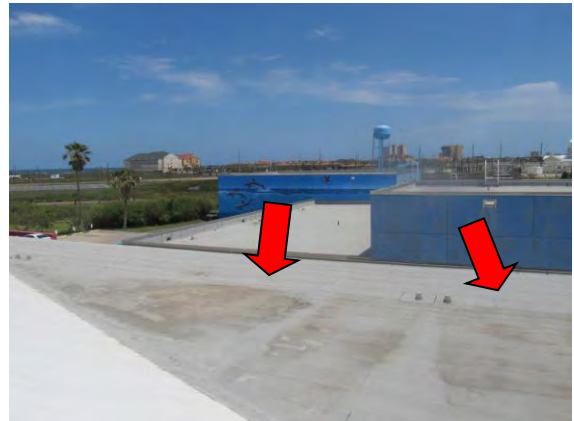
**Photo #70** Staining on capsheet membrane due to ponding conditions from inadequate roof slope.

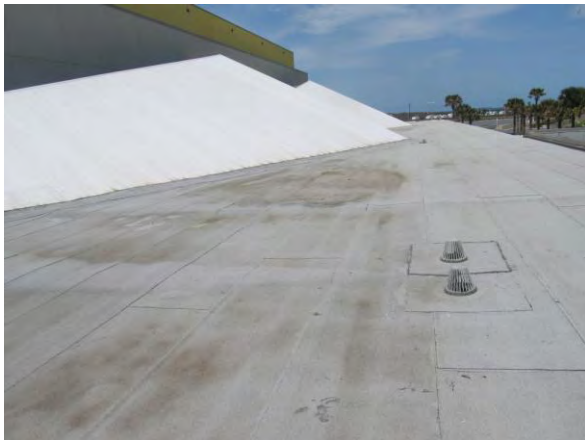
**Photo #71** Staining on lobby roof facing east.

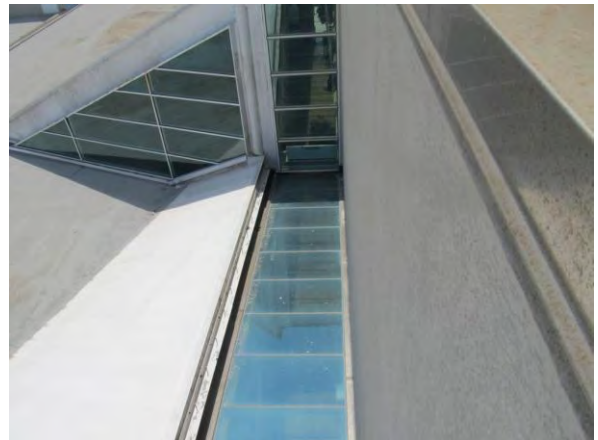
**Photo #72** Glazing system that slopes to gutter.

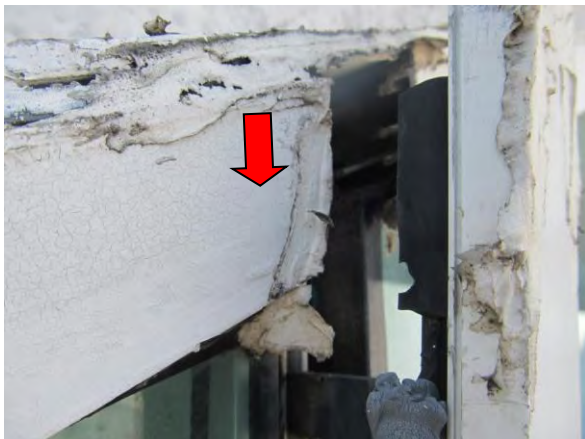
**Photo #77** Detail view of displaced mullion. Note sealant in poor condition.

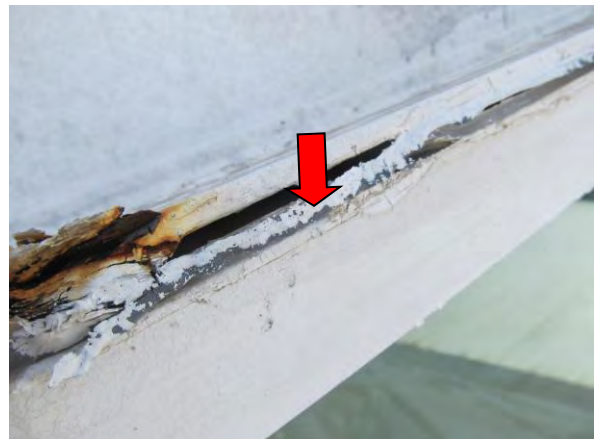
**Photo #78** Typical sealant failure at window/metal flashing interface.

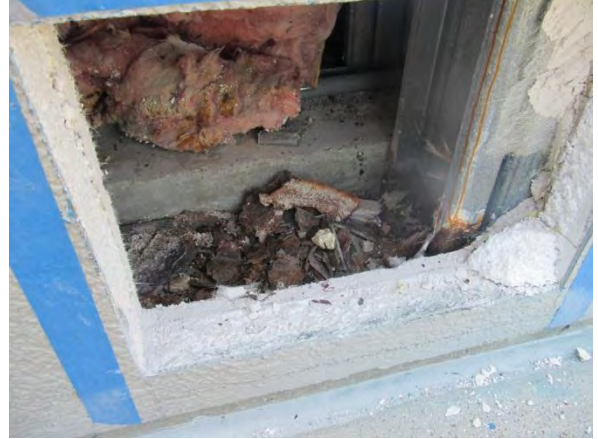
**Photo #2** DTO #1 – Corroded sill track with total loss.

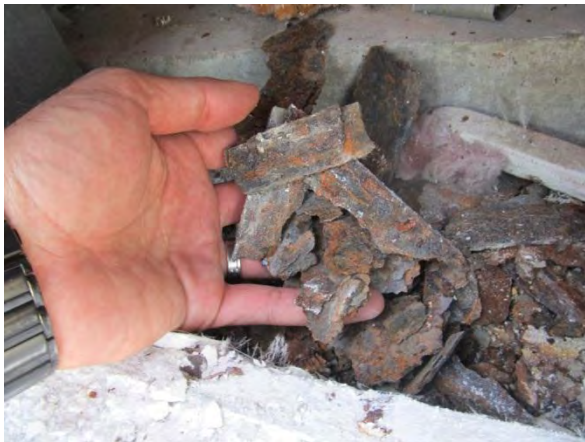
**Photo #3** DTO #1 – Corrosion scale along sill track.

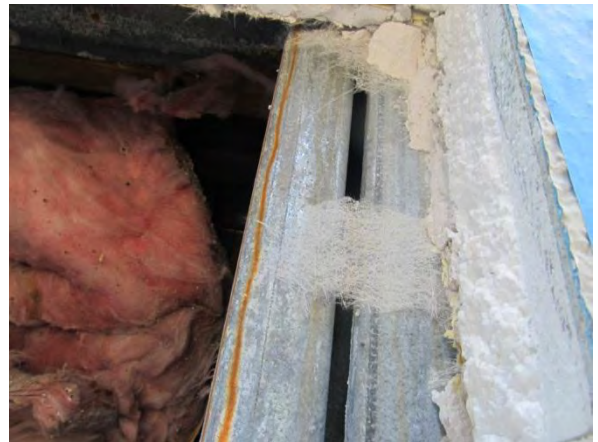
**Photo #4** DTO #1 – Water stains on vertical framing member from window above.

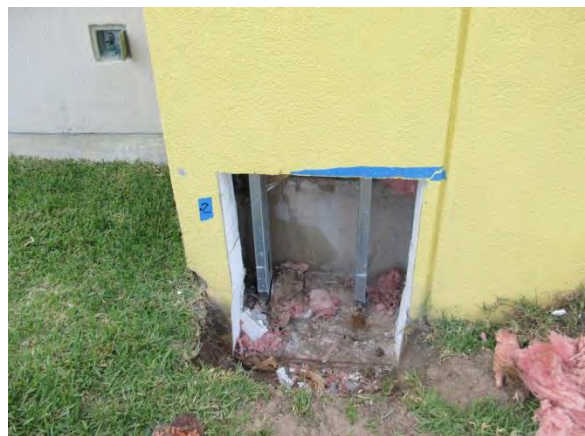
**Photo #5** DTO #2 - Taken along east elevation.

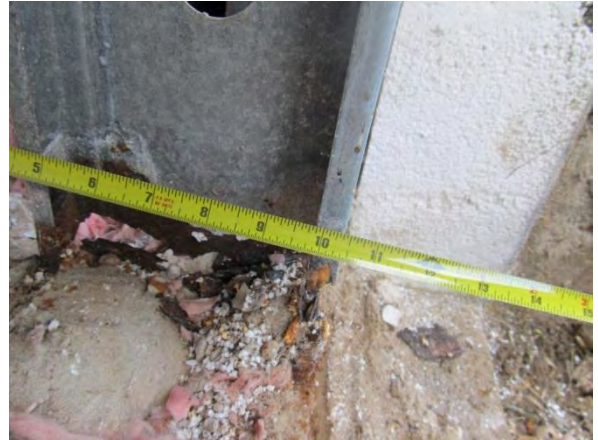
**Photo #8** DTO #3 – Corrosion along bottom of vertical framing member. Sill track was completely corroded.

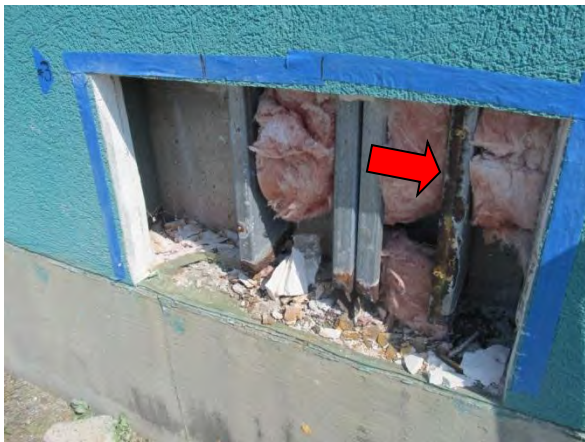
**Photo #9** DTO #3 – Typical corrosion along bottom sill track and vertical framing members. Note corrosion on vertical framing member believed to be impacted from water infiltration from windows above.

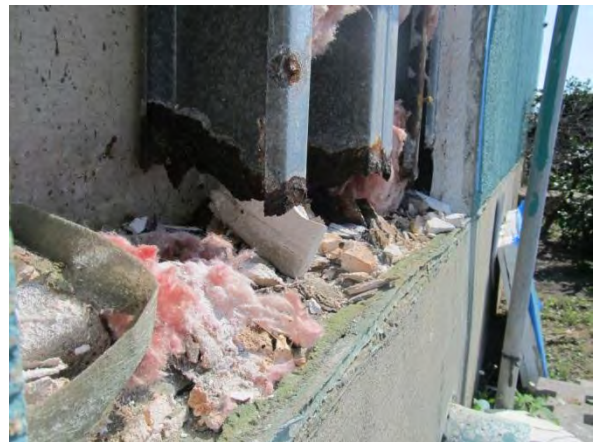
**Photo #10** DTO #3 - Total member loss of sill track and bottom of vertical framing members.
