# LIMITED BUILDING ENCLOSURE ASSESSMENT

**South Padre Island Convention Centre  
South Padre Island, Texas**

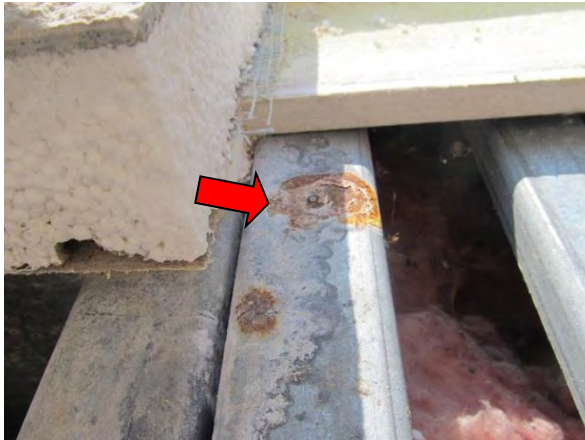
**Photo #13** DTO #4 – Minor corrosion at fastener.

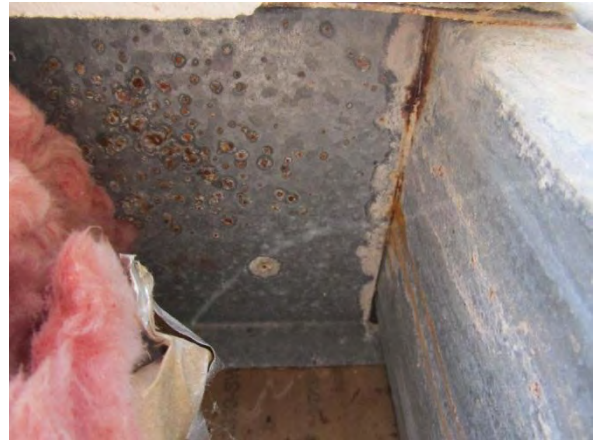
**Photo #14** DTO #4 – Corrosion on window sill as observed looking up wall.

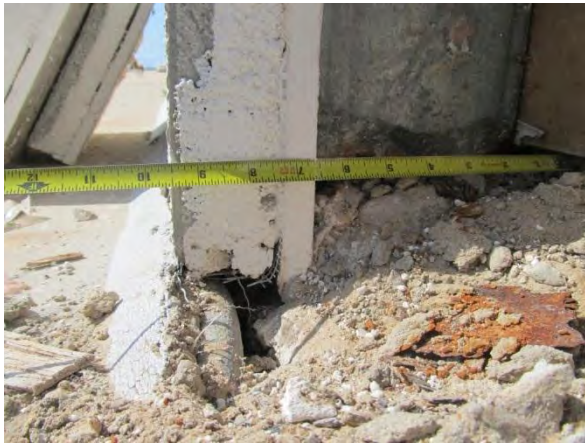
**Photo #15** DTO #5 – Significant corrosion along base of wall.

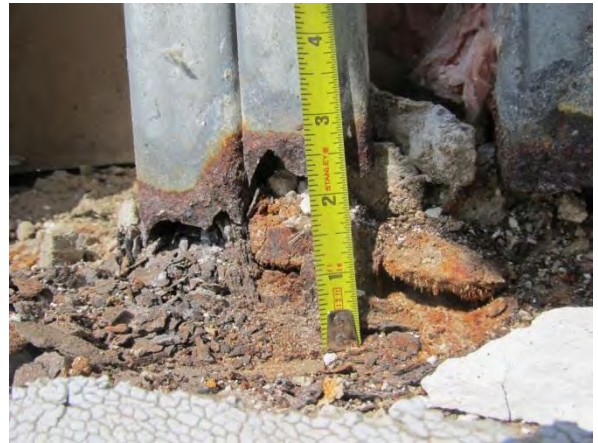
**Photo #16** DTO #5 - Corrosion along bottom sill track and vertical framing members.

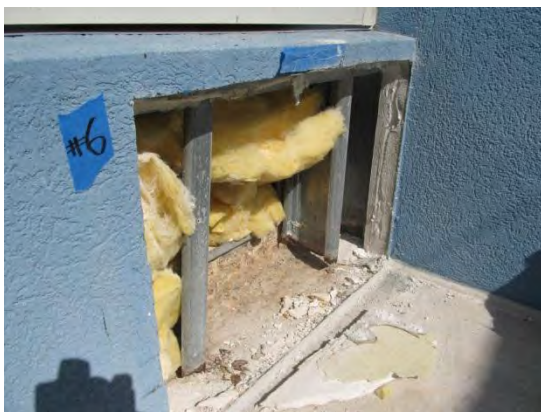
**Photo #17** DTO #6 – Taken along west elevation.

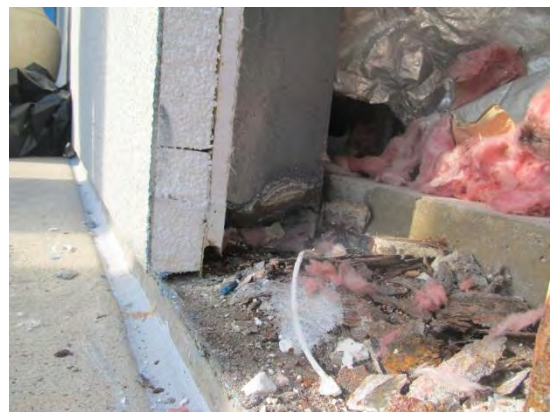
**Photo #18** DTO #6 Corroded sill track and bottom of vertical framing member.

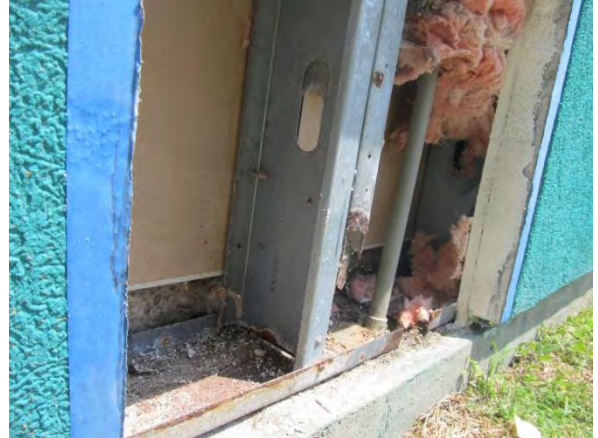
**Photo #20** DTO #7 – Minor corrosion along replaced sill track and vertical framing members.

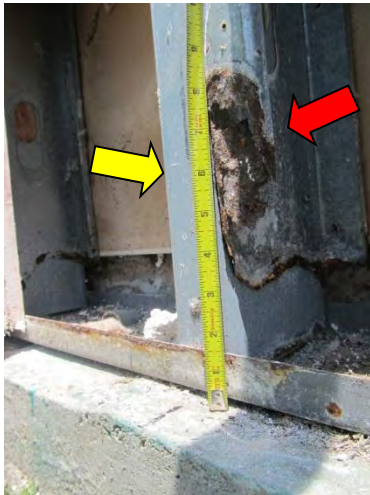
**Photo #21** DTO #7 – View of original vertical framing member (red arrow) and new framing member (yellow arrow).

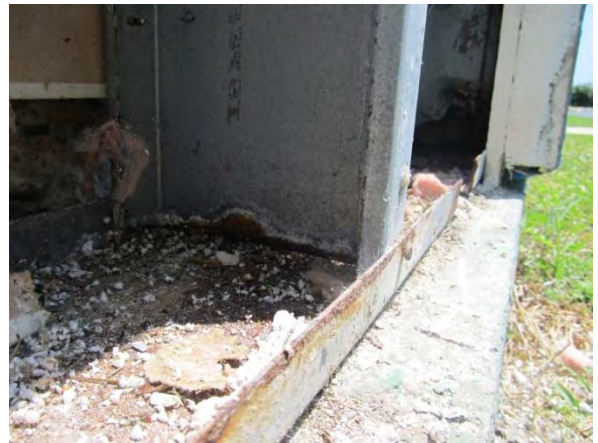
**Photo #22** DTO #7 – Minor corrosion of sill track and new vertical framing member.

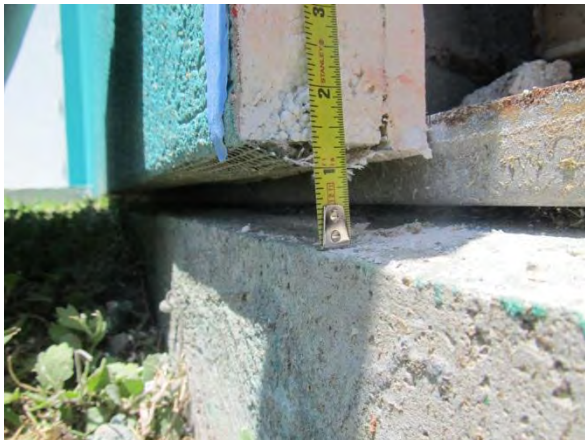
**Photo #23** DTO #7 – Improper EIFS termination at foundation. Note exposed backwrapping and missing sealant joint.

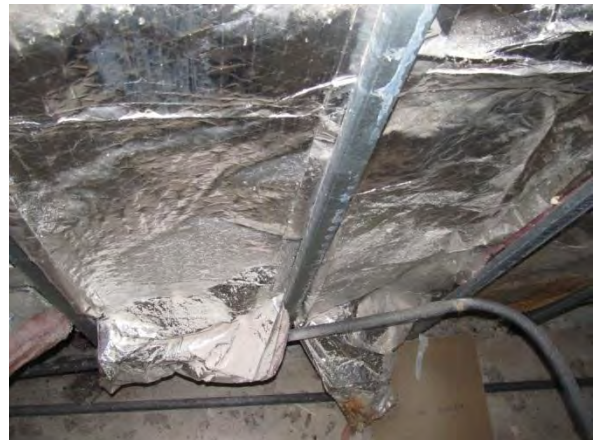
**Photo #24** Interior opening approximately 6' above Opening #10. No evidence of distress or moisture impacted materials were observed.

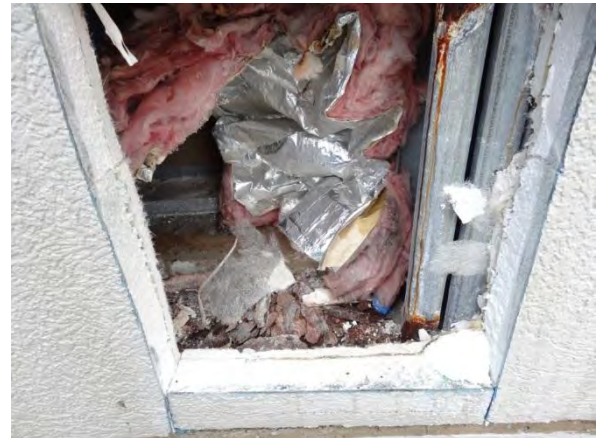
**Photo #4** Water observed migrating into wall assembly.

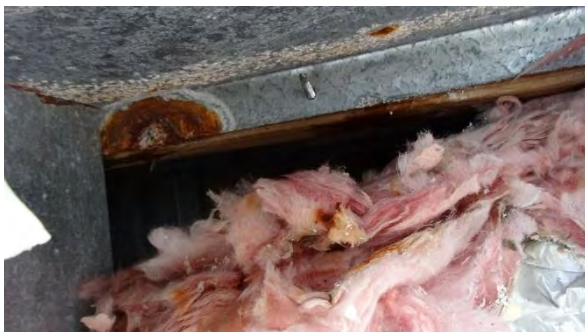
**Photo #5** Bottom of window sill. Water was observed on sill pan and wood blocking.

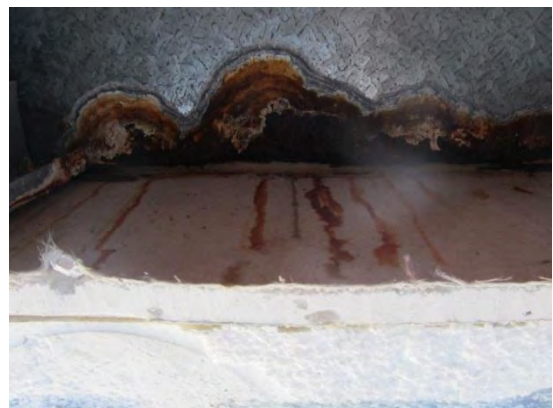
**Photo #6** Bottom of sill. Water stains along interior sheathing.

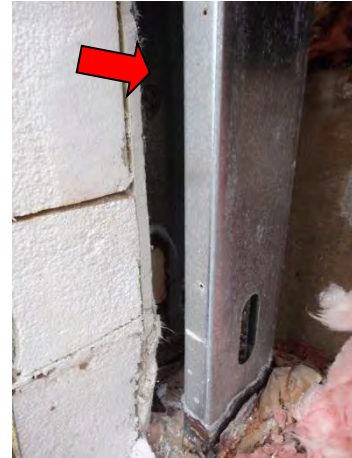
**Photo #8** Water observed migrating along EIFS termination and continuing down floor line.

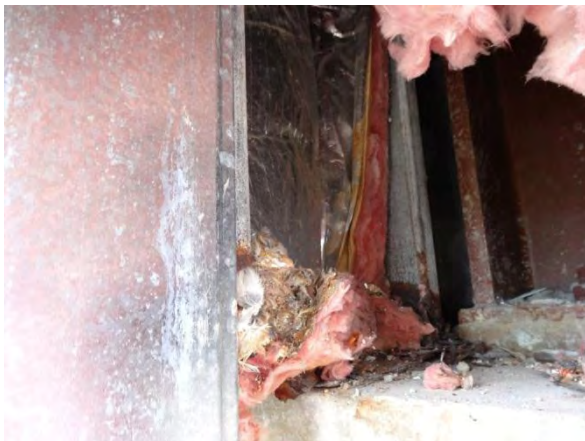
**Photo #9** Moisture impacted insulation during spray testing.

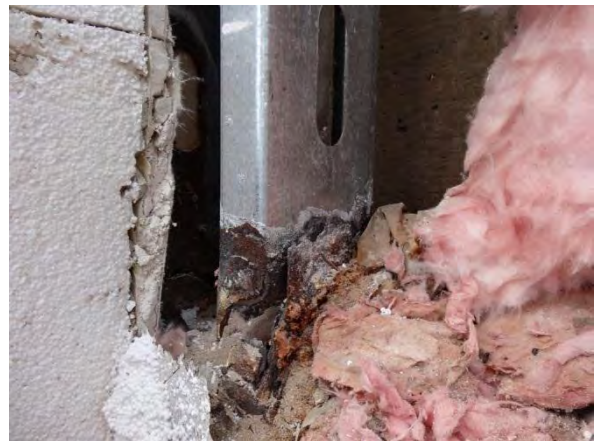
**Photo #10** Moisture impacted insulation and corrosion on vertical framing members.

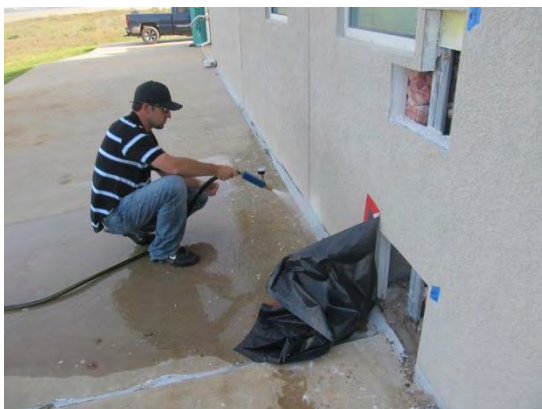
**Photo #11** Water spray testing in progress on DTO #5.

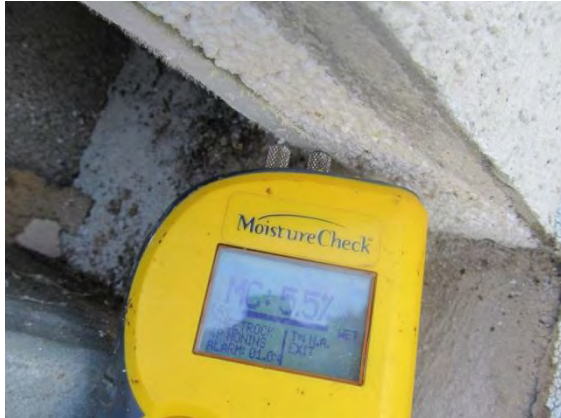
**Photo #13** Moisture probe reading of exterior gypsum sheathing during spray testing.

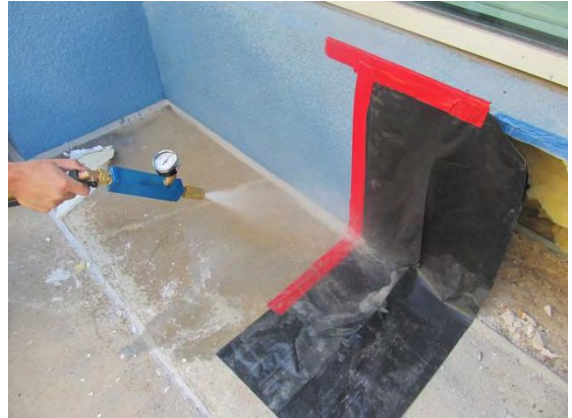
**Photo #14** Water spray testing in progress at DTO #6.

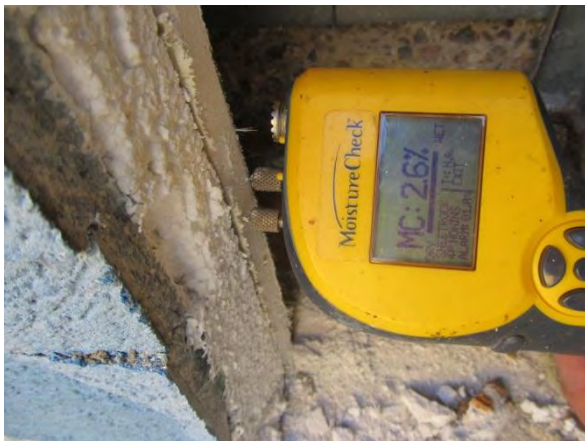
**Photo #15** Moisture probe reading of exterior gypsum sheathing during spray testing.

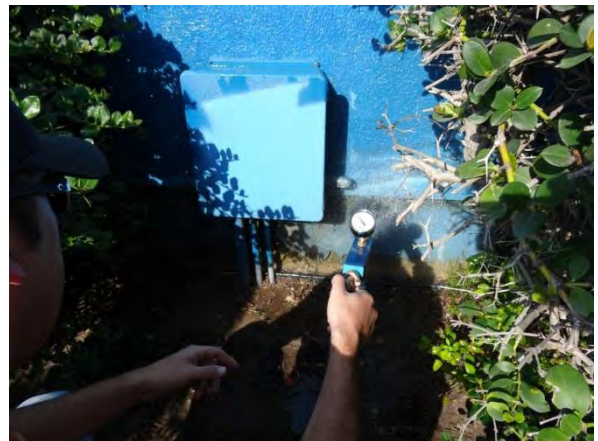
**Photo #16** Water spray testing near electrical conduit penetration on exterior "WyLand" wall.

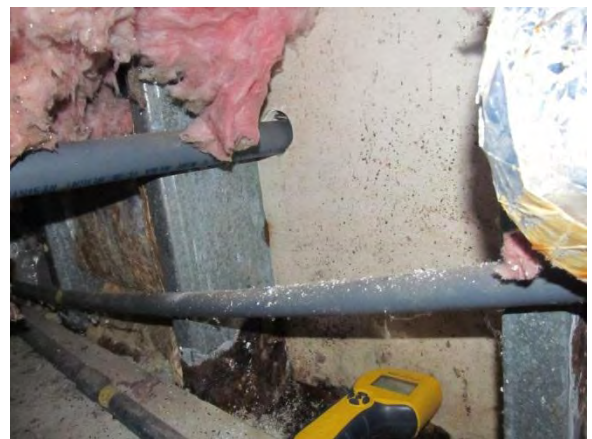
**Photo #18** Moisture probe reading of exterior gypsum sheathing (4.9%). Dampness was felt during spray testing referenced in previous photographs.

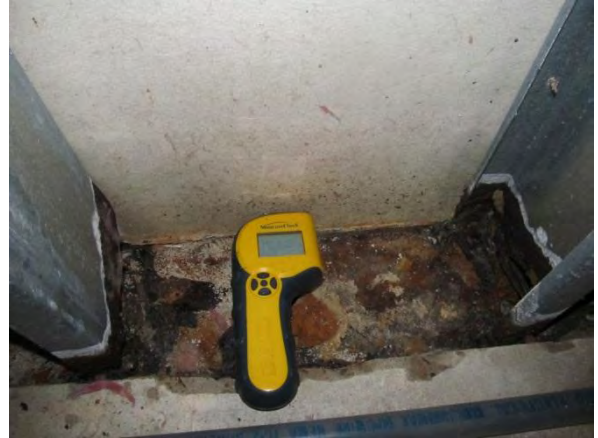
**Photo #20** Moisture probe reading on exterior gypsum sheathing (0.9%) during spray testing referenced in previous photo. Water was also felt on bottom sill.
