EXISTING FACILITIES NEEDS ASSESSMENT FOR
The South Padre Island Convention Center
For the
City of South Padre Island, Texas
June 1, 2012

Existing Facilities Needs
Assessment for The South Padre
Island Convention Center

Convention Center Assessment

Mechanical Systems Overview

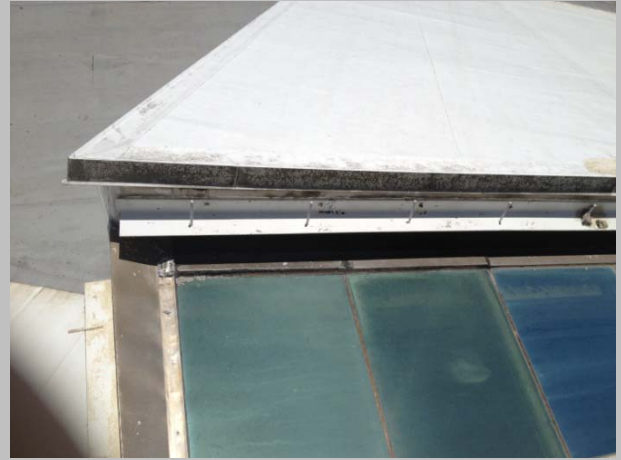
7. The storefront system located at the east lobby elevation consists of double-paned, glazed glass units meeting ANSI Z97.1 – 1984. This system does not meet the current standards set in IBC 2006 for Hurricane-Prone Regions. The same may be true for the louvers present at mechanical openings and the glazing at the canopy/main lobby skylight. (Photo #8 and #14)

Photo #8 Gutter system at central canopy/main lobby skylight.

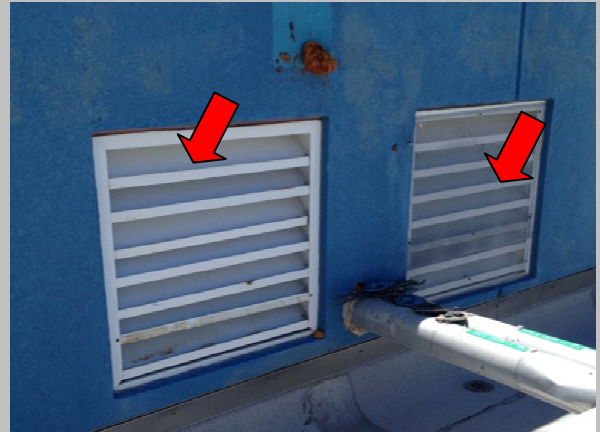
Photo #14 Louvers at mechanical openings.

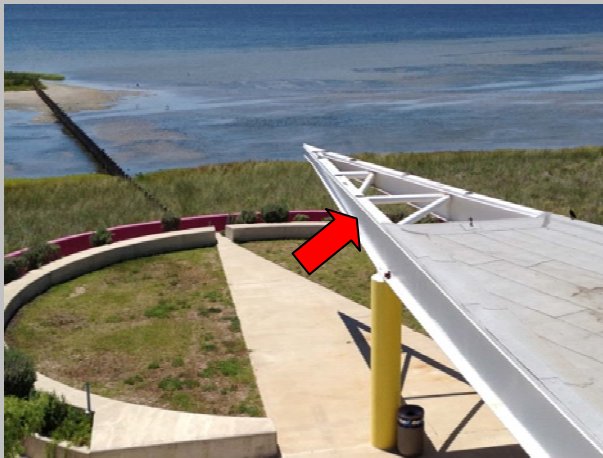
Photo #15 West side central canopy

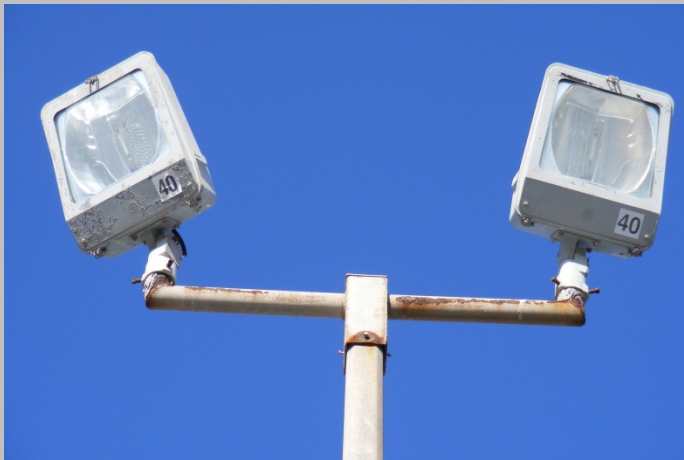
The parking lot lighting consists of metal halide fixtures mounted on steel cross arms and secured to concrete poles. The paint is peeling from the light fixtures and the cross arms are rusting. The concrete poles appear to be in operable condition.

Hand-hole covers are also missing at the base of some concrete poles, exposing the lighting branch conductors.

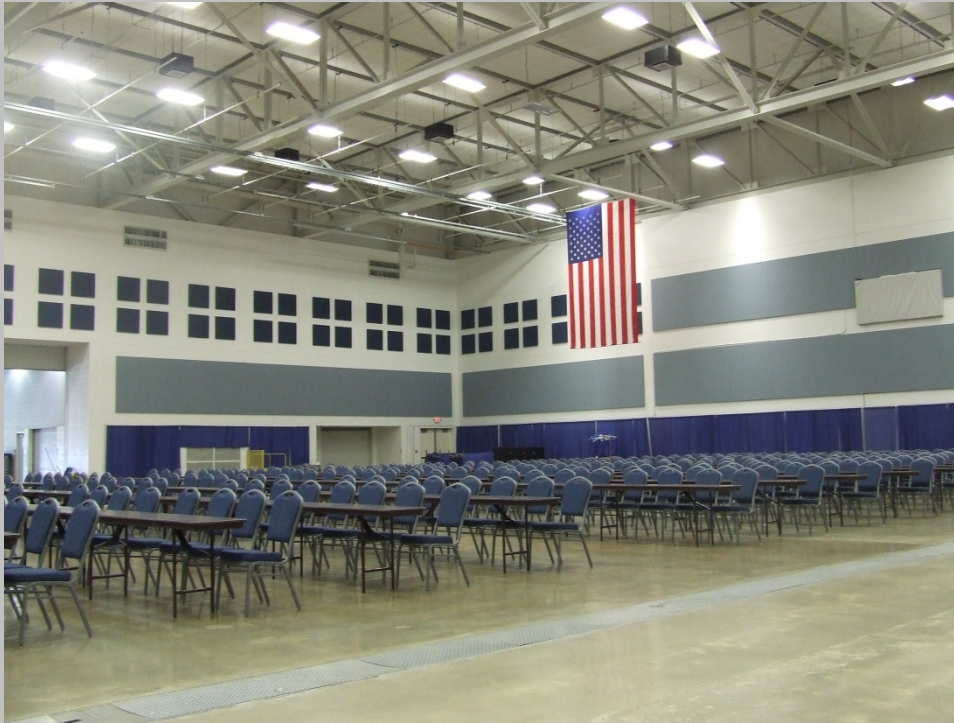
The majority of the interior lighting consists of linear fluorescent T8 and compact fluorescent lamps. The pendant-mounted down lights located in the main lobby utilize incandescent PAR lamps. The indirect lighting in the lobby utilize linear fluorescent T12 lamps. The lighting in the main ballroom consists of linear fluorescent T5HO, 6-lamp, high bay light fixtures in a 2x4 enclosure.

All linear fluorescent T12 lighting fixtures should be replaced with either T8 or T5 lamps since T12 lamps will no longer be manufactured in the near future, and they are less efficient. Incandescent down lights and pendant-mounted lighting fixtures should be replaced with more efficient compact fluorescent or LED lighting fixtures.

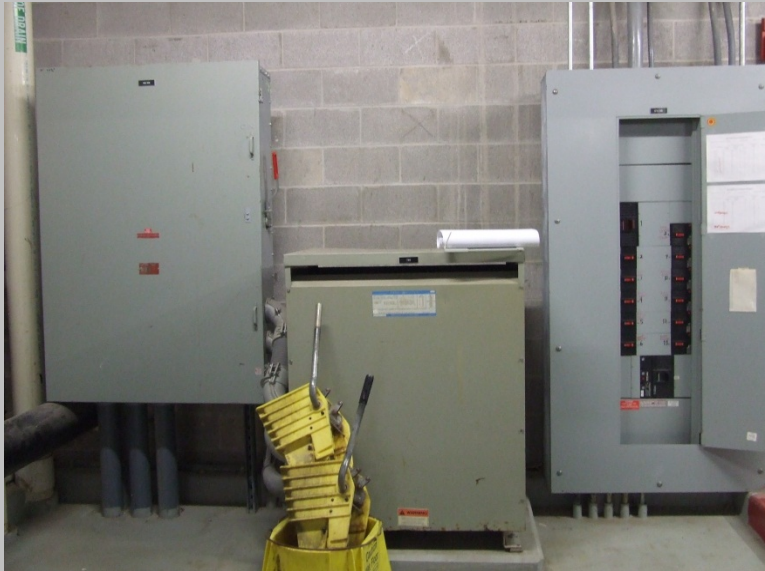
The electrical switchgear's manufacturer is General Electric (GE). The interior distribution panelboards and dry-type transformers appear to be in good condition. Dry-type transformers are approximately 20 years old, and are not as efficient per today's industry standards. Some panelboard directories are missing and the circuit breaker loads are not properly identified.

The main switchboard enclosure, located in the main electrical room, is beginning to show signs of corrosion. This is due to its close proximity to an exterior door, and the electrical room is not air conditioned.

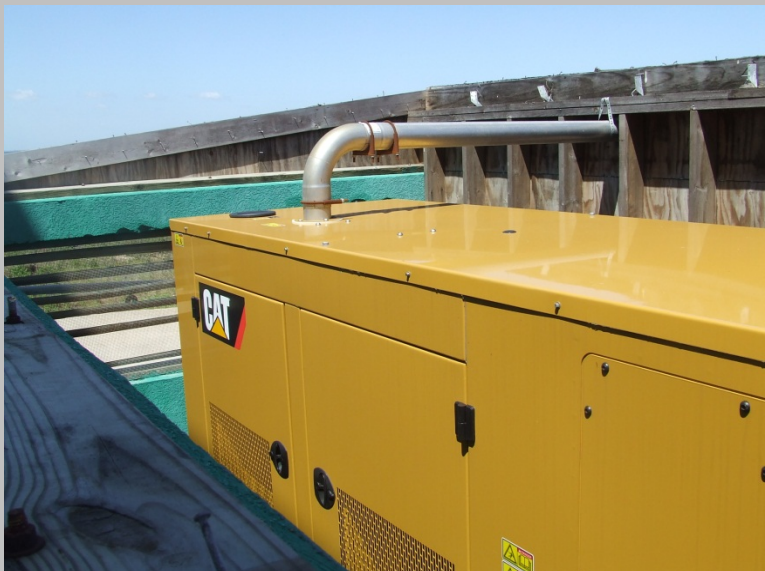
The emergency, stand-by diesel generator is rated for 125kW/156kVA at 480/277-Volts and was recently installed in 2012. It is installed in a weatherproof and sound attenuated enclosure, and it is located adjacent to the loading dock and main electrical room.

The generator is new and in great condition. If the generator's alternator windings were not coated with a marine epoxy sealant, the owner should contact the generator manufacturer to see if this coating can still be applied. This will prolong the life of the alternator. Space heaters should be installed inside of the generator's enclosure to reduce condensation if it was not initially provided with this accessory.

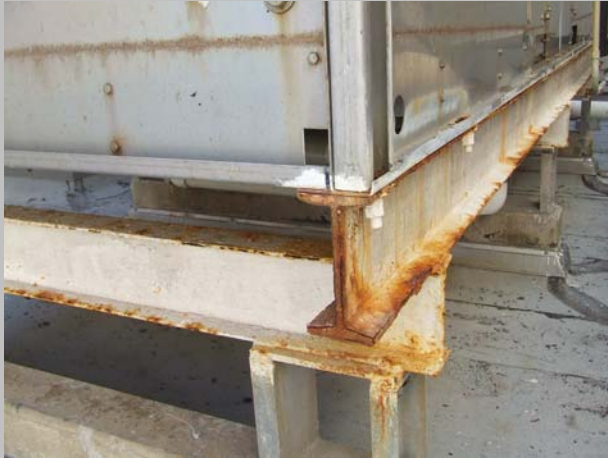
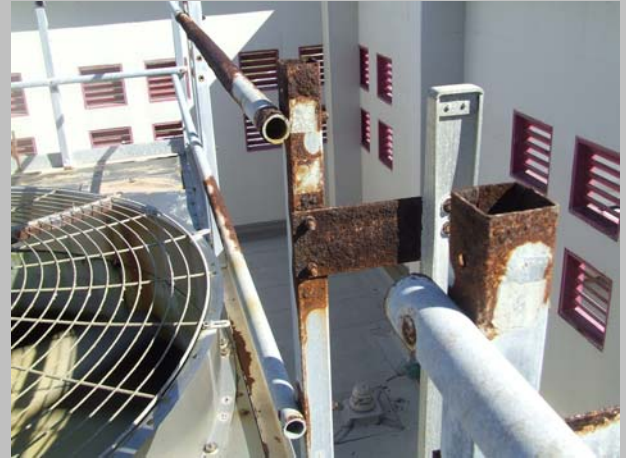
1. The centrifugal chillers, pumps and piping are in good repair and have a remaining life of at least 15 years.
2. The stainless steel cooling tower is twelve years old and should last another 8 to 10 years. Unfortunately the I-beam supports are carbon steel and may fail before the tower reaches the end of it's life.

3. All of the rooftop equipment and condensing units have a remaining useful life of 5 years or less due to corrosion.
